Access Compliance Report

Public Rights-of-Way

(Curb Ramps)

Intersection ID: 27570	Main Street: ALTON_FARM_LN	Cross Street: DEER RIDGE_LN	Location: W
ADA ID: E8EDDE6237F5	Ramp Type: PerpDiag	Initial Pass/Fail: Fail	Overall Compliance: No
Severity Score: 12.5			
Codes/Mitigation Info/Possible Solution		Field Measurements/Component Compliance

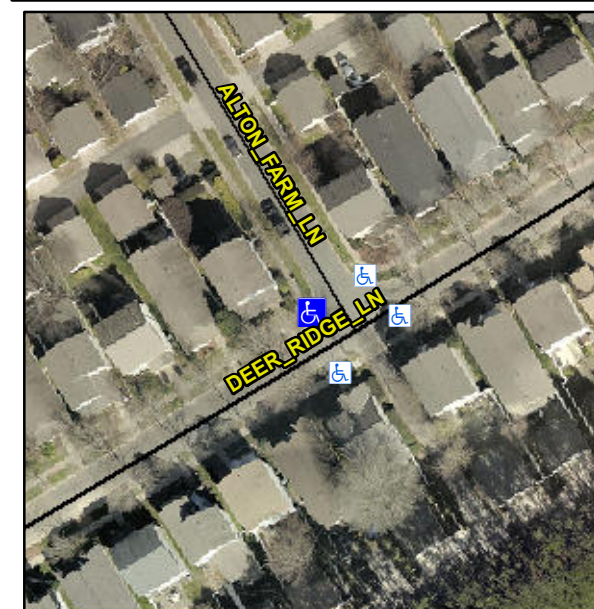
Compliance	Description	Data	Compliance	Description	Data
N/A	Ramp Length (in)	59.0	No	Ramp Slope (%)	10.9
Yes	Ramp Width (in)	48.0	Yes	Ramp XSlope (%)	2.0
N/A	Flare Type LT	N/A	N/A	Flare Type RT	N/A
N/A	Flare Slope LT (%)	N/A	N/A	Flare Slope RT (%)	N/A
N/A	Flare Traversable LT?	N/A	N/A	Flare Traversable RT?	N/A
N/A	Landing Length (in)	N/A	N/A	DWS Provided?	N/A
N/A	Landing Width (in)	N/A	N/A	DWS Contrast?	N/A
N/A	Landing Slope (%)	N/A	N/A	DWS Length (in)	N/A
N/A	Landing X Slope (%)	N/A	N/A	DWS Full Width?	N/A
N/A	Landing Curb? (Y/N)	N/A	N/A	DWS Offset (in)	N/A
N/A	Shared Landing?	N/A			
N/A	Gutter Ponding?	N/A	N/A	Gutter Slope (%)	N/A
N/A	Gutter Lip Ht (in)	N/A	N/A	Gutter X Slope (%)	N/A
N/A	Painted X Walk1?	No	N/A	Painted X Walk2?	No
	X Walk 1 Direction	To S		X Walk 2 Direction	To NE
N/A	X Walk 1 Width (in)	N/A	N/A	X Walk 2 Width (in)	N/A
	X Walk 1 Slope (%)	3.8		X Walk 2 Slope (%)	0.5
	X Walk 1 X Slope (%)	0.3		X Walk 2 X Slope (%)	2.0

N/A	Ramp inside XWalk1?	N/A	N/A	Ramp inside XWalk2?	N/A
	Road Slope (%)	1.5	N/A	Clear Space?	N/A
	Road X Slope (%)	1.8	N/A	Clear Space to XWalk (in)	N/A
N/A	Any Obstructions?	N/A	N/A	Storm Grate/Utility Hazard?	N/A
	Obstruction Type			Storm Grate/Utility Type	
		N/A			N/A
			Yes	Surface Condition? (G/P)	Good

Possible Solutions:

Remove & Replace Curb Ramp With Two New Directional Ramps or Equivalent.
