# Access Compliance Report

## Public Rights-of-Way

| Intersection ID: 22417 | Main Street: BRACKENBURY_LN | Cross Street: N_BRACKENBURY_LN | Location: E |
| ADA ID: E8EF15ACDCF0 | Ramp Type: PerpDiag | Initial Pass/Fail: Fail | Overall Compliance: No |

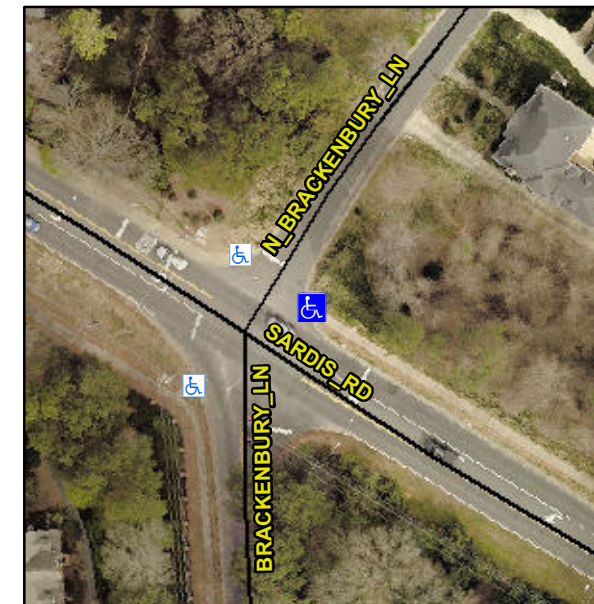
| | | Severity Score: 10 | |

**Not Found, R304.5.1, R304.5.3**

| Compliance | Description | Data | Compliance | Description | Data |
|---|---|---|---|---|---|
| N/A | Ramp Length (in) | 60.0 | Yes | Ramp Slope (%) | 6.0 |
| No | Ramp Width (in) | 46.0 | No | Ramp XSlope (%) | 3.5 |

**Remove & Replace Curb Ramp With Two New Directional Ramps or Equivalent.**

Total Cost: \$ 3200.00
