Access Compliance Report

Public Rights-of-Way

(Curb Ramps)

Intersection ID: 24484	Main Street: SAINTFIELD_PL	Cross Street: SWINFORD_PL	Location: SE
ADA ID: E8F6E0DA755C	Ramp Type: Perp	Initial Pass/Fail: Fail	Overall Compliance: No
Severity Score: 13.75			
Codes/Mitigation Info/Possible Solution		Field Measurements/Component Compliance

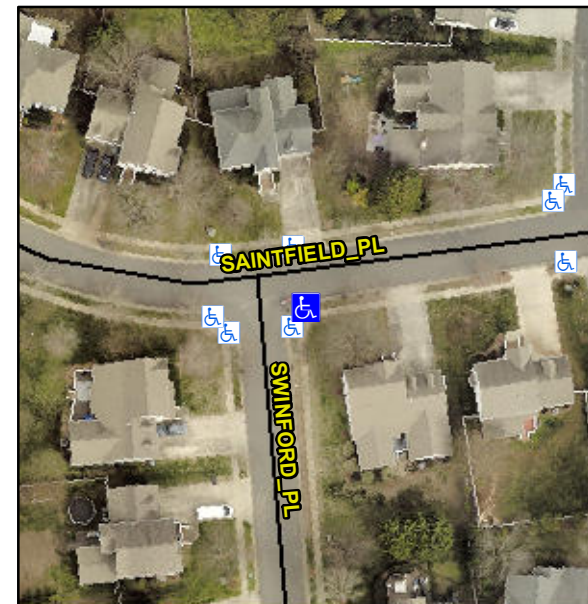
Not Found, R304.2.2, R304.5.3

Compliance	Description	Data	Compliance	Description	Data
N/A	Ramp Length (in)	48.0	No	Ramp Slope (%)	8.4
Yes	Ramp Width (in)	48.0	No	Ramp XSlope (%)	2.1
N/A	Flare Type LT	N/A	N/A	Flare Type RT	N/A
N/A	Flare Slope LT (%)	N/A	N/A	Flare Slope RT (%)	N/A
N/A	Flare Traversable LT?	N/A	N/A	Flare Traversable RT?	N/A
N/A	Landing Length (in)	N/A	N/A	DWS Provided?	N/A
N/A	Landing Width (in)	N/A	N/A	DWS Contrast?	N/A
N/A	Landing Slope (%)	N/A	N/A	DWS Length (in)	N/A
N/A	Landing X Slope (%)	N/A	N/A	DWS Full Width?	N/A
N/A	Landing Curb? (Y/N)	N/A	N/A	DWS Offset (in)	N/A
N/A	Shared Landing?	N/A			
N/A	Gutter Ponding?	N/A	N/A	Gutter Slope (%)	N/A
N/A	Gutter Lip Ht (in)	N/A	N/A	Gutter X Slope (%)	N/A
N/A	Painted X Walk1?	No	N/A	Painted X Walk2?	N/A
	X Walk 1 Direction	To N		X Walk 2 Direction	N/A
N/A	X Walk 1 Width (in)	N/A	N/A	X Walk 2 Width (in)	N/A
	X Walk 1 Slope (%)	3.8		X Walk 2 Slope (%)	N/A
	X Walk 1 X Slope (%)	1.0		X Walk 2 X Slope (%)	N/A

N/A	Ramp inside XWalk1?	N/A	N/A	Ramp inside XWalk2?	N/A
	Road Slope (%)	N/A	N/A	Clear Space?	N/A
	Road X Slope (%)	N/A	N/A	Clear Space to XWalk (in)	N/A
N/A	Any Obstructions?	N/A	N/A	Storm Grate/Utility Hazard?	N/A
	Obstruction Type			Storm Grate/Utility Type	
		N/A			N/A
			Yes	Surface Condition? (G/P)	Good

Remove & Replace Entire Ramp.

Total Cost: \$ 1850.00
