Access Compliance Report

Public Rights-of-Way

(Curb Ramps)

Intersection ID: 23717	Main Street: E WESTINGHOUSE BV	Cross Street: CHINA GROVE CHURCH RD	Location: NE
ADA ID: E8FB4B51A1E8	Ramp Type: PerpDiag	Initial Pass/Fail: Fail	Overall Compliance: No
Codes/Mitigation Info/Possible Solution		Field Measurements/Component Compliance	
Severity Score: 12.5

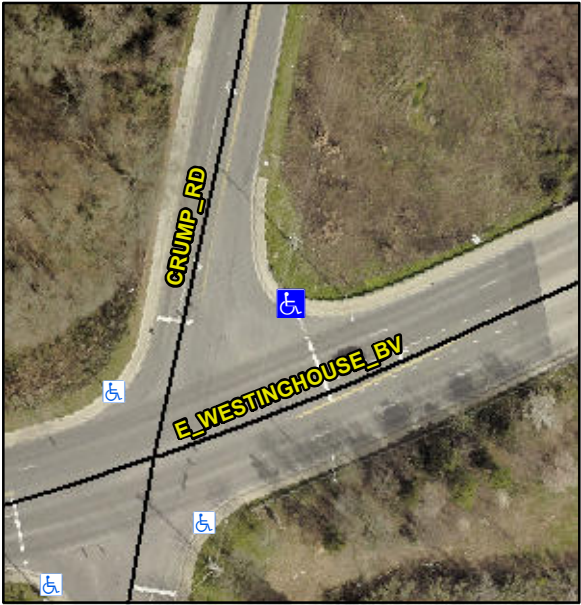
Possible Solutions:		Compliance	Description	Data	Compliance	Description	Data
	Remove & Replace Curb Ramp With Two New Directional Ramps or Equivalent.		N/A	Ramp Length (in)	61.0	No	Ramp Slope (%)	10.8
<p>Surveyor Notes:</p> <p>N/A</p> <p>PROW/ADA:</p> <p>Not Found, R304.2.2</p>			Yes	Ramp Width (in)	51.0	Yes	Ramp XSlope (%)	0.9
			N/A	Flare Type LT	N/A	N/A	Flare Type RT	N/A
<p>Street 1 Name</p> <p>CRUMP RD</p> <p>Stop Condition-Street 2</p> <p>Signal</p> <p>Street 2 Name</p> <p>E WESTINGHOUSE BV</p> <p>Stop Condition-Street 1</p> <p>Signal</p>			N/A	Flare Slope LT (%)	N/A	N/A	Flare Slope RT (%)	N/A
			N/A	Flare Traversable LT?	N/A	N/A	Flare Traversable RT?	N/A
<p>Total Cost:</p> <p>\$ 3200.00</p>			N/A	Landing Length (in)	N/A	N/A	DWS Provided?	N/A
			N/A	Landing Width (in)	N/A	N/A	DWS Contrast?	N/A
			N/A	Landing Slope (%)	N/A	N/A	DWS Length (in)	N/A
			N/A	Landing X Slope (%)	N/A	N/A	DWS Full Width?	N/A

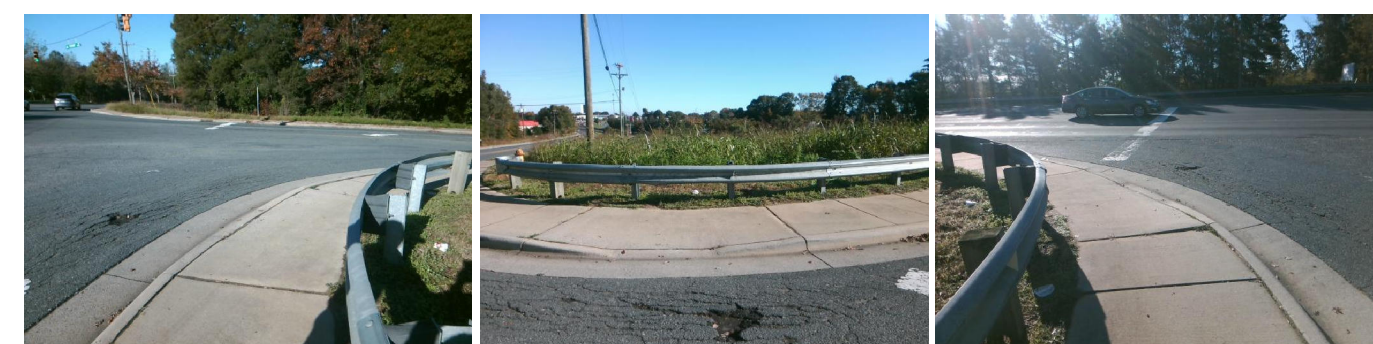
N/A	Landing Curb? (Y/N)	N/A	N/A	DWS Offset (in)	N/A
			N/A	Shared Landing?	N/A			
			N/A	Gutter Ponding?	N/A	N/A	Gutter Slope (%)	N/A
			N/A	Gutter Lip Ht (in)	N/A	N/A	Gutter X Slope (%)	N/A
			N/A	Painted X Walk1?	No	N/A	Painted X Walk2?	No
				X Walk 1 Direction	To W		X Walk 2 Direction	To SW
			N/A	X Walk 1 Width (in)	N/A	N/A	X Walk 2 Width (in)	N/A
				X Walk 1 Slope (%)	0.9		X Walk 2 Slope (%)	3.1
				X Walk 1 X Slope (%)	1.8		X Walk 2 X Slope (%)	0.6
			N/A	Ramp inside XWalk1?	N/A	N/A	Ramp inside XWalk2?	N/A
				Road Slope (%)	1.6	N/A	Clear Space?	N/A
				Road X Slope (%)	1.8	N/A	Clear Space to XWalk (in)	N/A
			N/A	Any Obstructions?	N/A	N/A	Storm Grate/Utility Hazard?	N/A
				Obstruction Type			Storm Grate/Utility Type	
			N/A			N/A		N/A
			Yes	Surface Condition? (G/P)				Good
