# Access Compliance Report

## Public Rights-of-Way

### (Curb Ramps)

Intersection ID: 48135	Main Street: HIGHLAND_CREEK_PY	Cross Street: SQUIRREL_TRAIL_LN	Location: NE
ADA ID: E90A6B6C97A4	Ramp Type: Perp	Initial Pass/Fail: Fail	Overall Compliance: No
		Severity Score: 8.75

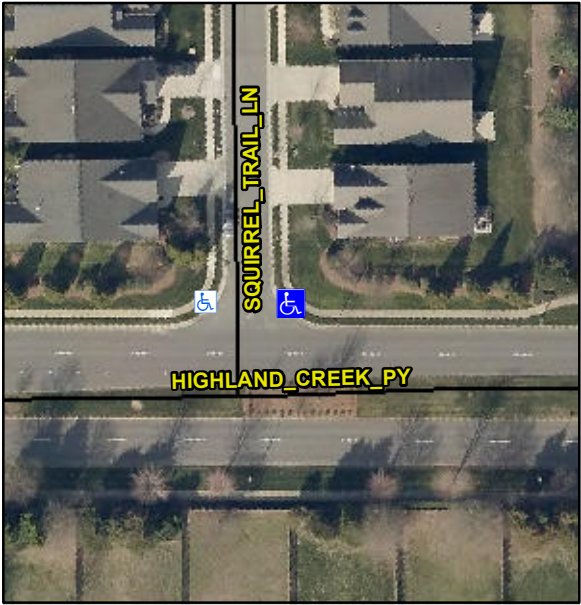
Possible Solutions:		<b>Compliance</b>	<b>Description</b>	<b>Data</b>	
	<b>Remove &amp; Replace Entire Ramp.</b>		<b>N/A</b>	Ramp Length (in)	<b>47.5</b>	<b>Yes</b>
			<b>No</b>	Ramp Width (in)	<b>47.0</b>	<b>Yes</b>
			<b>N/A</b>	Flare Type LT	<b>N/A</b>	<b>N/A</b>
			<b>N/A</b>	Flare Slope LT (%)	<b>N/A</b>	<b>N/A</b>
			<b>N/A</b>	Flare Traversable LT?	<b>N/A</b>	<b>N/A</b>
			<b>N/A</b>	Landing Length (in)	<b>N/A</b>	<b>N/A</b>
			<b>N/A</b>	Landing Width (in)	<b>N/A</b>	<b>N/A</b>
			<b>N/A</b>	Landing Slope (%)	<b>N/A</b>	<b>N/A</b>
			<b>N/A</b>	Landing X Slope (%)	<b>N/A</b>	<b>N/A</b>
			<b>N/A</b>	Landing Curb? (Y/N)	<b>N/A</b>	<b>N/A</b>
			<b>N/A</b>	Shared Landing?	<b>N/A</b>	
			<b>N/A</b>	Gutter Ponding?	<b>N/A</b>	<b>N/A</b>
			<b>N/A</b>	Gutter Lip Ht (in)	<b>N/A</b>	<b>N/A</b>
			<b>N/A</b>	Painted X Walk1?	<b>No</b>	<b>N/A</b>

X Walk 1 Direction	<b>To W</b>	<b>N/A</b>
			<b>N/A</b>	X Walk 1 Width (in)	<b>N/A</b>	<b>N/A</b>
				X Walk 1 Slope (%)	<b>2.4</b>	<b>N/A</b>
				X Walk 1 X Slope (%)	<b>0.9</b>	<b>N/A</b>
			<b>N/A</b>	Ramp inside XWalk1?	<b>N/A</b>	<b>N/A</b>
<p>Surveyor Notes:</p> <p><b>N/A</b></p> <p>PROW/ADA:</p> <p><b>Not Found, R304.5.1</b></p>			<b>N/A</b>	Road Slope (%)	<b>N/A</b>	<b>N/A</b>
			<b>N/A</b>	Road X Slope (%)	<b>N/A</b>	<b>N/A</b>
			<b>N/A</b>	Any Obstructions?	<b>N/A</b>	<b>N/A</b>
				Obstruction Type		
					<b>N/A</b>	<b>N/A</b>
			<b>Yes</b>	Surface Condition? (G/P)	<b>Good</b>	
Total Cost:		\$ 1850.00
