Access Compliance Report Public Rights-of-Way (Curb Ramps)

Intersection ID: 54154 Main Street: DEWEY_CREEK_LN Cross Street: MAPLE_CREEK_CT Location: SE

ADA ID: E90D152F587D Ramp Type: BlendTrans1 Initial Pass/Fail: Fail Overall Compliance: No Severity Score: 1.25

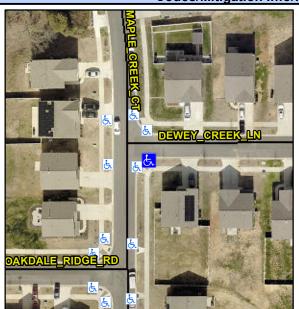
Not Found, R304.5.3

Yes N/A Ramp Length (in) 98.0 BlendTrans Slope (%) 3.8 No Yes Ramp Width (in) 48.0 BlendTrans XSlope (%) 2.3 N/A N/A Flare Type LT N/A Flare Type RT N/A N/A Flare Slope LT (%) N/A N/A Flare Slope RT (%) N/A N/A Flare Traversable LT? N/A N/A Flare Traversable RT? N/A N/A Landing Length (in) N/A N/A **DWS Provided?** N/A N/A Landing Width (in) N/A N/A **DWS Contrast?** N/A N/A N/A N/A Landing Slope (%) DWS Length (in) N/A N/A Landing X Slope (%) N/A N/A DWS Full Width? N/A N/A Landing Curb? (Y/N) N/A N/A DWS Offset (in) N/A N/A N/A Shared Landing? N/A **Gutter Ponding?** N/A N/A Gutter Slope (%) N/A N/A Gutter Lip Ht (in) 1.5 N/A Gutter X Slope (%) N/A N/A Painted X Walk1? No N/A Painted X Walk2? N/A X Walk 1 Direction To N X Walk 2 Direction N/A N/A X Walk 1 Width (in) X Walk 2 Width (in) N/A X Walk 1 Slope (%) 1.0 X Walk 2 Slope (%) N/A X Walk 1 X Slope (%) 0.6 X Walk 2 X Slope (%) N/A N/A N/A Ramp inside XWalk2? N/A Ramp inside XWalk1? N/A Road Slope (%) 0.6 Clear Space? N/A N/A Road X Slope (%) Clear Space to XWalk (in) N/A 1.0 N/A N/A N/A Any Obstructions? Storm Grate/Utility Hazard? N/A **Obstruction Type** Storm Grate/Utility Type N/A N/A Yes Surface Condition? (G/P) Good No Curb Slope (%) 12.7

Remove & Replace Curb Ramp With Two New Directional Ramps or Equivalent.

Total Cost: \$ 3200.00
