# Access Compliance Report

## Public Rights-of-Way

### (Curb Ramps)

| Intersection ID: 43075 | Main Street: SCOTT_AV | Cross Street: ROMANY_RD | Location: S |

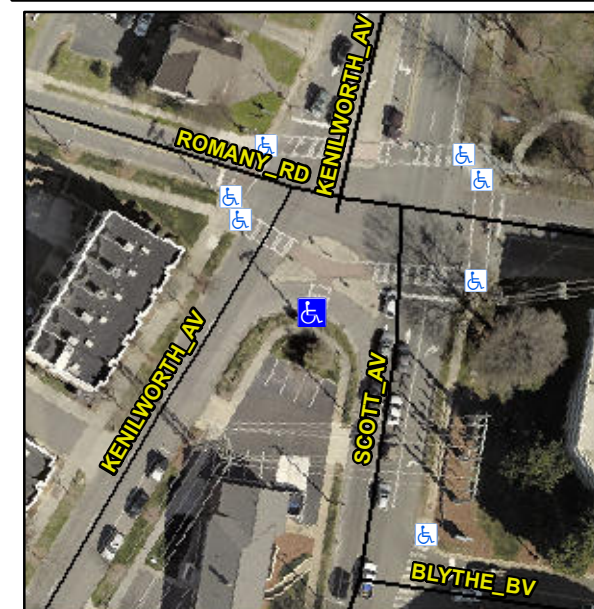
| ADA ID: E9144644DAFF | Ramp Type: Perp | Initial Pass/Fail: Fail | Overall Compliance: No |
| Severity Score: 41.25 | | | |

**Not Found, R304.2.2, R304.5.3, R302.7**

| Compliance | Description | Data | Compliance | Description | Data |
|---|---|---|---|---|---|
| N/A | Ramp Length (in) | 45.0 | No | Ramp Slope (%) | 19.7 |
| Yes | Ramp Width (in) | 48.0 | No | Ramp XSlope (%) | 3.7 |
| | | No | | Surface Condition? (G/P) | Poor |

**Remove & Replace Entire Ramp.**

Total Cost: \$ 1850.00
