Access Compliance Report Public Rights-of-Way (Curb Ramps)

Intersection ID: 15199 Main Street: GREENBROOK DR **Cross Street: WOODHILL LN** Location: ADA ID: E915CDF74116 Ramp Type: PerpDiag Initial Pass/Fail: Fail **Overall Compliance: No Severity Score:** 22.5

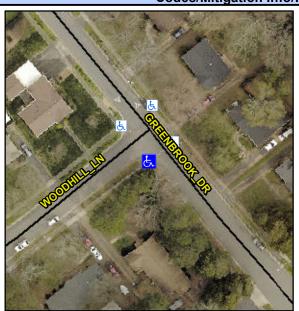
Field Measurements/Component Compliance							
	Compliance Description		Data	Comp	liance	Description	Data
ı	N/A	Ramp Length (in)	50.5	No	Ramp	Slope (%)	10.9

-	No	Ramp Width (in)	41.0	No	Ramp	XSlope (%)	4.9
1	N/A	Flare Type LT	N/A	N/A	Flare	Type RT	N/A
ı	N/A	Flare Slope LT (%)	N/A	N/A	Flare	Slope RT (%)	N/A
ı	N/A	Flare Traversable LT?	N/A	N/A	Flare	Traversable RT?	N/A
ı	N/A	Landing Length (in)	N/A	N/A	DWS	Provided?	N/A
ı	N/A	Landing Width (in)	N/A	N/A	DWS	Contrast?	N/A
ı	N/A	Landing Slope (%)	N/A	N/A	DWS	Length (in)	N/A
ı	N/A	Landing X Slope (%)	N/A	N/A	DWS	Full Width?	N/A
ı	N/A	Landing Curb? (Y/N)	N/A	N/A	DWS	Offset (in)	N/A
ı	N/A	Shared Landing?	N/A				
ı	N/A	Gutter Ponding?	N/A	N/A	Gutte	r Slope (%)	N/A
ı	N/A	Gutter Lip Ht (in)	N/A	N/A	Gutte	r X Slope (%)	N/A
ı	N/A	Painted X Walk1?	No	N/A	Paint	ed X Walk2?	No
		X Walk 1 Direction	To NE		X Wa	lk 2 Direction	To NW
ı	N/A	X Walk 1 Width (in)	N/A	N/A	X Wa	lk 2 Width (in)	N/A
		X Walk 1 Slope (%)	4.9		X Wa	lk 2 Slope (%)	1.6
		X Walk 1 X Slope (%)	5.4		X Wa	lk 2 X Slope (%)	0.1
ı	N/A	Ramp inside XWalk1?	N/A	N/A	Ramp	inside XWalk2?	N/A

Road Slope (%)	4.2	N/A	Clear	Space?	N/A
		Road X Slope (%)	1.3	N/A	Clear	Space to XWalk (in)	N/A
ı	N/A	Any Obstructions?	N/A	N/A	Storm	Grate/Utility Hazard?	N/A
		Obstruction Type			Storm	n Grate/Utility Type	
			N/A				N/A
				Yes	Surfa	ce Condition? (G/P)	Good
58	- 3	A TENTON

Possible Solutions: **Remove & Replace Curb Ramp With** Two New Directional Ramps or Equivalent. Surveyor Notes: N/A PROW/ADA: Not Found, R304.5.1, R304.2.2, R304.5.3
