Access Compliance Report

Public Rights-of-Way

(Curb Ramps)

| Intersection ID: 43839 | Main Street: DELUCA_DR | Cross Street: HAMEL_ST | Location: SW |

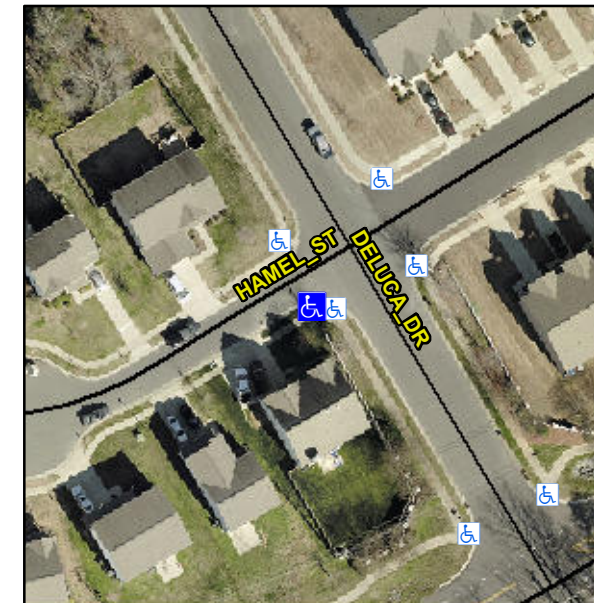
| ADA ID: E916A917B206 | Ramp Type: Perp | Initial Pass/Fail: Fail | Overall Compliance: No |
| | | Severity Score: 12.5 | |

Not Found, R304.2.2

| Compliance | Description | Data | Compliance | Description | Data |
|---|---|---|---|---|---|
| N/A | Ramp Length (in) | 47.5 | No | Ramp Slope (%) | 9.1 |
| Yes | Ramp Width (in) | 48.0 | Yes | Ramp XSlope (%) | 0.7 |

Possible Solutions:

Remove & Replace Entire Ramp.

Total Cost: \$ 1850.00
