# Access Compliance Report

## Public Rights-of-Way

### (Curb Ramps)

Intersection ID: 30383	Main Street: BELLSOUTH_DR	Cross Street: CENTRAL_AV	Location: SW
ADA ID: E921842A6788	Ramp Type: Perp	Initial Pass/Fail: Fail	Overall Compliance: No
Severity Score: 8.75			
Codes/Mitigation Info/Possible Solution		Field Measurements/Component Compliance

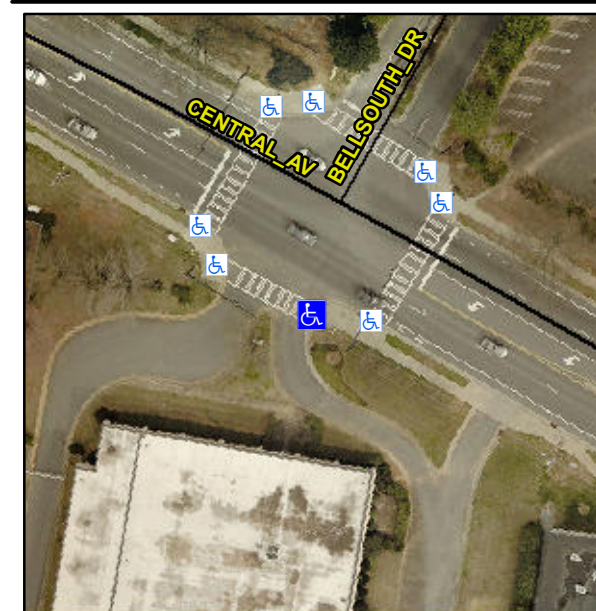
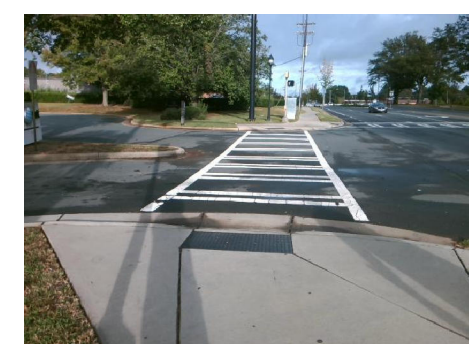
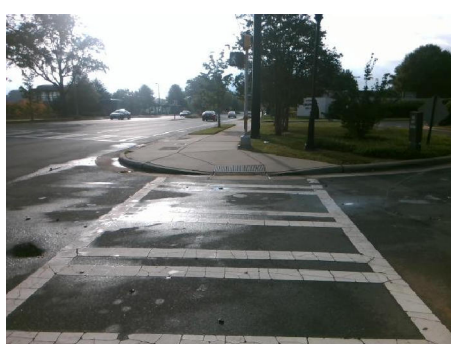
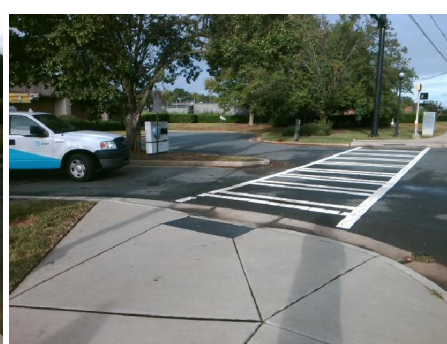
**Not Found, R304.5.1**

Compliance	Description	Data	Compliance	Description	Data
N/A	Ramp Length (in)	28.5	Yes	Ramp Slope (%)	5.3
No	Ramp Width (in)	47.0	Yes	Ramp XSlope (%)	1.1
N/A	Flare Type LT	N/A	N/A	Flare Type RT	N/A
N/A	Flare Slope LT (%)	N/A	N/A	Flare Slope RT (%)	N/A
N/A	Flare Traversable LT?	N/A	N/A	Flare Traversable RT?	N/A
N/A	Landing Length (in)	N/A	N/A	DWS Provided?	N/A
N/A	Landing Width (in)	N/A	N/A	DWS Contrast?	N/A
N/A	Landing Slope (%)	N/A	N/A	DWS Length (in)	N/A
N/A	Landing X Slope (%)	N/A	N/A	DWS Full Width?	N/A
N/A	Landing Curb? (Y/N)	N/A	N/A	DWS Offset (in)	N/A
N/A	Shared Landing?	N/A			
N/A	Gutter Ponding?	N/A	N/A	Gutter Slope (%)	N/A
N/A	Gutter Lip Ht (in)	N/A	N/A	Gutter X Slope (%)	N/A
N/A	Painted X Walk1?	Yes	N/A	Painted X Walk2?	N/A
	X Walk 1 Direction	To NW		X Walk 2 Direction	N/A
N/A	X Walk 1 Width (in)	116.0	N/A	X Walk 2 Width (in)	N/A
	X Walk 1 Slope (%)	0.1		X Walk 2 Slope (%)	N/A
	X Walk 1 X Slope (%)	0.5		X Walk 2 X Slope (%)	N/A

N/A	Ramp inside XWalk1?	Yes	N/A	Ramp inside XWalk2?	N/A
	Road Slope (%)	N/A	N/A	Clear Space?	N/A
	Road X Slope (%)	N/A	N/A	Clear Space to XWalk (in)	N/A
N/A	Any Obstructions?	N/A	N/A	Storm Grate/Utility Hazard?	N/A
	Obstruction Type			Storm Grate/Utility Type	
		N/A			N/A
		Yes		Surface Condition? (G/P)	Good

**Remove & Replace Entire Ramp.**
