Access Compliance Report

Public Rights-of-Way

(Curb Ramps)

Intersection ID: 11882	Main Street: N_PINE_ST	Cross Street: W_5TH_ST	Location: S
ADA ID: E924475C39CF	Ramp Type: Directional1	Initial Pass/Fail: Pass	Overall Compliance: No
Severity Score: 5.25			
Codes/Mitigation Info/Possible Solution		Field Measurements/Component Compliance

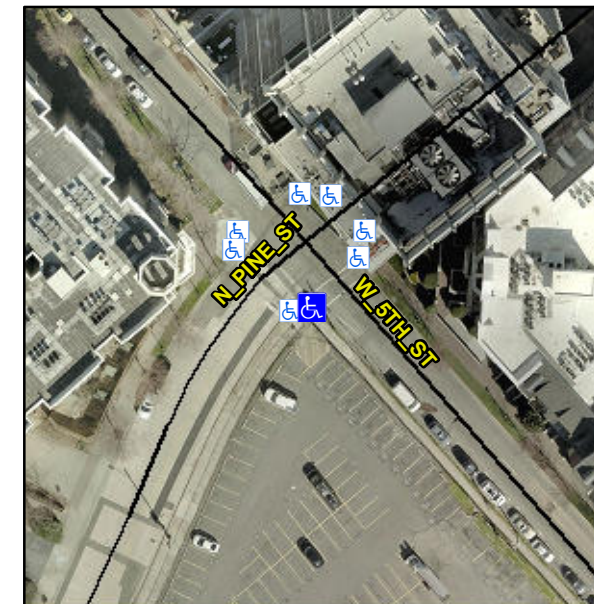
Compliance	Description	Data	Compliance	Description	Data
N/A	Ramp Length (in)	91.0	Yes	Grade Break?	Yes
Yes	Ramp Width (in)	51.0	No	Grade Break Slope (%)	7.9
Yes	Ramp Slope (%)	6.1	Yes	Grade Break XSlope (%)	0.3
No	Ramp XSlope (%)	4.6			
N/A	Flare Type LT	N/A	No	Flare Type RT	N/A
N/A	Flare Slope LT (%)	N/A	N/A	Flare Slope RT (%)	N/A
N/A	Flare Traversable LT?	N/A	N/A	Flare Traversable RT?	No
Yes	Landing Length (in)	60.0	Yes	DWS Provided?	Yes
Yes	Landing Width (in)	53.0	Yes	DWS Contrast?	Yes
Yes	Landing Slope (%)	0.9	Yes	DWS Length (in)	24.0
No	Landing X Slope (%)	2.8	Yes	DWS Full Width?	Yes
N/A	Landing Curb? (Y/N)	N/A	Yes	DWS Offset LT (in)	11.0
N/A	Shared Landing?	Yes	Yes	DWS Offset RT (in)	2.0
Yes	Gutter Ponding?	No	Yes	Gutter Slope (%)	2.6
Yes	Gutter Lip Ht (in)	0.0	Yes	Gutter X Slope (%)	0.4
N/A	Painted X Walk1?	Yes		Road Slope (%)	5.0
	X Walk 1 Direction	To NE		Road X Slope (%)	0.8
	X Walk 1 Width (in)	110.0		Clear Space?	Yes

X Walk 1 Slope (%)	5.0	N/A	Clear Space to XWalk (in)	N/A
	X Walk 1 X Slope (%)	0.8	Yes	Storm Grate/Utility Hazard?	No
Yes	Ramp inside XWalk1?	Yes		Storm Grate/Utility Type	
Yes	Any Obstructions?	No			N/A
	Obstruction Type		Yes	Surface Condition? (G/P)	Good
			N/A	Curb Slope (%)	7.6

Possible Solutions:

Remove & Replace Entire Ramp.

PROW/ADA:

R304.5.3, R304.2.3
