Access Compliance Report

Public Rights-of-Way

(Curb Ramps)

Intersection ID: 5014	Main Street: CRANBERRY_NOOK_CT	Cross Street: HEDGECREST_PL	Location: S
ADA ID: E928C6A4878E	Ramp Type: Perp	Initial Pass/Fail: Fail	Overall Compliance: No
			Severity Score: 25

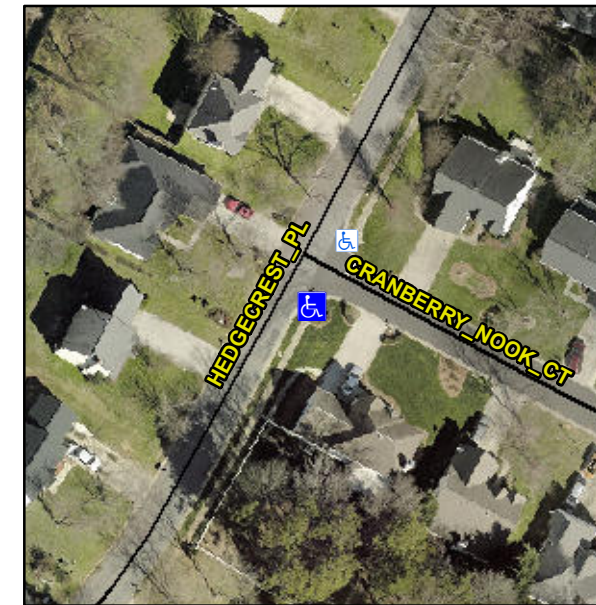
Not Found, R304.2.2

Compliance	Description	Data	Compliance	Description	Data
N/A	Ramp Length (in)	50.0	No	Ramp Slope (%)	12.0
Yes	Ramp Width (in)	48.0	Yes	Ramp XSlope (%)	1.6
N/A	Flare Type LT	N/A	N/A	Flare Type RT	N/A
N/A	Flare Slope LT (%)	N/A	N/A	Flare Slope RT (%)	N/A
N/A	Flare Traversable LT?	N/A	N/A	Flare Traversable RT?	N/A
N/A	Landing Length (in)	N/A	N/A	DWS Provided?	N/A
N/A	Landing Width (in)	N/A	N/A	DWS Contrast?	N/A
N/A	Landing Slope (%)	N/A	N/A	DWS Length (in)	N/A
N/A	Landing X Slope (%)	N/A	N/A	DWS Full Width?	N/A
N/A	Landing Curb? (Y/N)	N/A	N/A	DWS Offset (in)	N/A
N/A	Shared Landing?	N/A			
N/A	Gutter Ponding?	N/A	N/A	Gutter Slope (%)	N/A
N/A	Gutter Lip Ht (in)	N/A	N/A	Gutter X Slope (%)	N/A
N/A	Painted X Walk1?	No	N/A	Painted X Walk2?	N/A
	X Walk 1 Direction	To NE		X Walk 2 Direction	N/A
N/A	X Walk 1 Width (in)	N/A	N/A	X Walk 2 Width (in)	N/A
	X Walk 1 Slope (%)	2.3		X Walk 2 Slope (%)	N/A
	X Walk 1 X Slope (%)	2.6		X Walk 2 X Slope (%)	N/A

Remove & Replace Entire Ramp.
