Access Compliance Report

Public Rights-of-Way

(Curb Ramps)

Intersection ID: 27440	Main Street: BALLANTYNE_COMMONS_PY	Cross Street: DOWINGTON_DR	Location: SW
ADA ID: E92BE0E64045	Ramp Type: BlendTrans1	Initial Pass/Fail: Fail	Overall Compliance: No
		Severity Score: 17.5

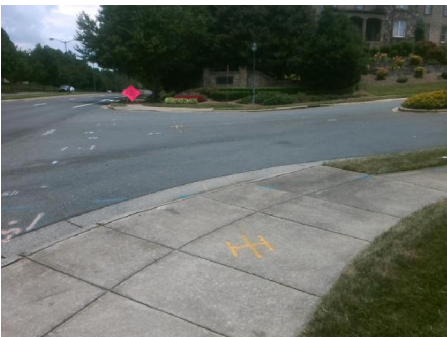
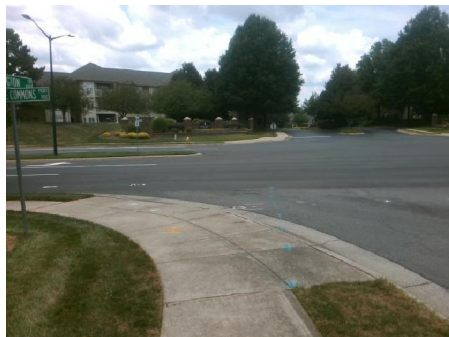
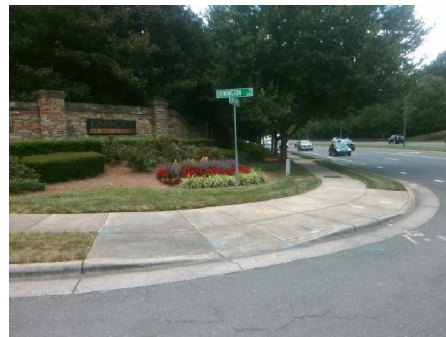
Not Found, R304.5.1

Compliance	Description	Data	Compliance	Description	Data
N/A	Ramp Length (in)	108.0	Yes	BlendTrans Slope (%)	3.8
No	Ramp Width (in)	32.0	Yes	BlendTrans XSlope (%)	1.5
N/A	Flare Type LT	N/A	N/A	Flare Type RT	N/A
N/A	Flare Slope LT (%)	N/A	N/A	Flare Slope RT (%)	N/A
N/A	Flare Traversable LT?	N/A	N/A	Flare Traversable RT?	N/A
N/A	Landing Length (in)	N/A	N/A	DWS Provided?	N/A
N/A	Landing Width (in)	N/A	N/A	DWS Contrast?	N/A
N/A	Landing Slope (%)	N/A	N/A	DWS Length (in)	N/A
N/A	Landing X Slope (%)	N/A	N/A	DWS Full Width?	N/A
N/A	Landing Curb? (Y/N)	N/A	N/A	DWS Offset (in)	N/A
N/A	Shared Landing?	N/A			
N/A	Gutter Ponding?	N/A	N/A	Gutter Slope (%)	N/A
N/A	Gutter Lip Ht (in)	N/A	N/A	Gutter X Slope (%)	N/A
N/A	Painted X Walk1?	No	N/A	Painted X Walk2?	N/A
	X Walk 1 Direction	To E		X Walk 2 Direction	N/A
	X Walk 1 Width (in)	N/A		X Walk 2 Width (in)	N/A
	X Walk 1 Slope (%)	2.2		X Walk 2 Slope (%)	N/A
	X Walk 1 X Slope (%)	2.3		X Walk 2 X Slope (%)	N/A

N/A	Ramp inside XWalk1?	N/A	N/A	Ramp inside XWalk2?	N/A
	Road Slope (%)	2.3		Clear Space?	N/A
	Road X Slope (%)	2.2	N/A	Clear Space to XWalk (in)	N/A
N/A	Any Obstructions?	N/A	N/A	Storm Grate/Utility Hazard?	N/A
	Obstruction Type			Storm Grate/Utility Type	
		N/A			N/A
			Yes	Surface Condition? (G/P)	Good
			No	Curb Slope (%)	23.1

Remove & Replace Curb Ramp With Two New Directional Ramps or Equivalent.
