Access Compliance Report

Public Rights-of-Way

(Curb Ramps)

Intersection ID: N/A	Main Street: CHELVESTON_DR	Cross Street: WALTON_RD	Location: NW
ADA ID: E92D09F181EB	Ramp Type: BlendTrans1	Initial Pass/Fail: Fail	Overall Compliance: No
Severity Score: 25			
Codes/Mitigation Info/Possible Solution		Field Measurements/Component Compliance

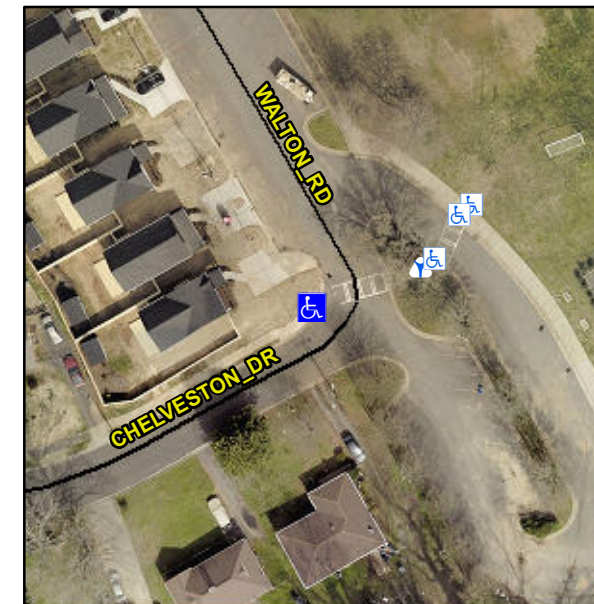
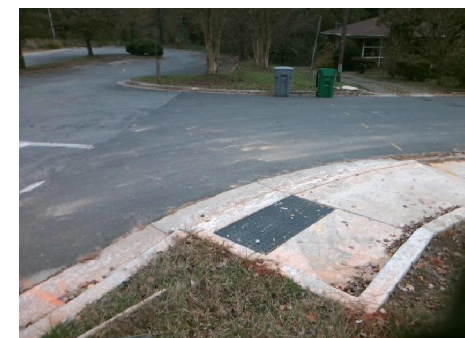
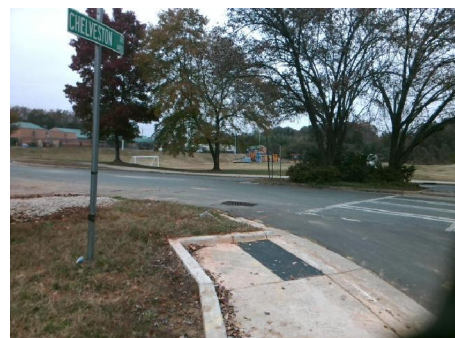
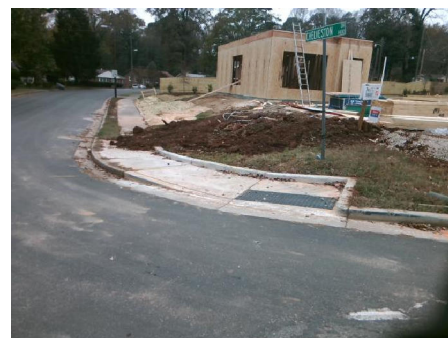
Not Found, R304.5.3

Compliance	Description	Data	Compliance	Description	Data
N/A	Ramp Length (in)	59.0	Yes	BlendTrans Slope (%)	1.6
Yes	Ramp Width (in)	61.0	No	BlendTrans XSlope (%)	7.5
N/A	Flare Type LT	N/A	N/A	Flare Type RT	N/A
N/A	Flare Slope LT (%)	N/A	N/A	Flare Slope RT (%)	N/A
N/A	Flare Traversable LT?	No	N/A	Flare Traversable RT?	No
N/A	Landing Length (in)	N/A	N/A	DWS Provided?	N/A
N/A	Landing Width (in)	N/A	N/A	DWS Contrast?	N/A
N/A	Landing Slope (%)	N/A	N/A	DWS Length (in)	N/A
N/A	Landing X Slope (%)	N/A	N/A	DWS Full Width?	N/A
N/A	Landing Curb? (Y/N)	N/A	N/A	DWS Offset (in)	N/A
N/A	Shared Landing?	N/A			
N/A	Gutter Ponding?	N/A	N/A	Gutter Slope (%)	N/A
N/A	Gutter Lip Ht (in)	N/A	N/A	Gutter X Slope (%)	N/A
N/A	Painted X Walk1?	No	N/A	Painted X Walk2?	Yes
	X Walk 1 Direction	To S		X Walk 2 Direction	To E
	X Walk 1 Width (in)	N/A		X Walk 2 Width (in)	103.0
	X Walk 1 Slope (%)	3.4		X Walk 2 Slope (%)	3.1
	X Walk 1 X Slope (%)	6.9		X Walk 2 X Slope (%)	5.6

N/A	Ramp inside XWalk1?	N/A	N/A	Ramp inside XWalk2?	Yes
	Road Slope (%)	7.8		Clear Space?	N/A
	Road X Slope (%)	2.5	N/A	Clear Space to XWalk (in)	N/A
N/A	Any Obstructions?	N/A	N/A	Storm Grate/Utility Hazard?	N/A
	Obstruction Type			Storm Grate/Utility Type	
		N/A			N/A
			Yes	Surface Condition? (G/P)	Good
			No	Curb Slope (%)	9.5

Remove & Replace Curb Ramp With Two New Directional Ramps or Equivalent.

Total Cost: \$ 3200.00
