# Access Compliance Report

## Public Rights-of-Way

### (Curb Ramps)

Intersection ID: 14655	Main Street: CAMERON_AV	Cross Street: E_5TH_ST	Location: NE
ADA ID: E934E039E68F	Ramp Type: Perp	Initial Pass/Fail: Fail	Overall Compliance: No
Codes/Mitigation Info/Possible Solution		Field Measurements/Component Compliance	
Severity Score: 13.75

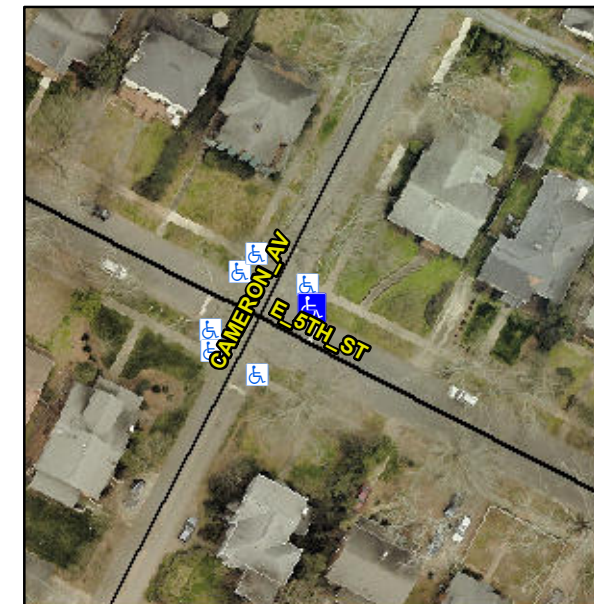
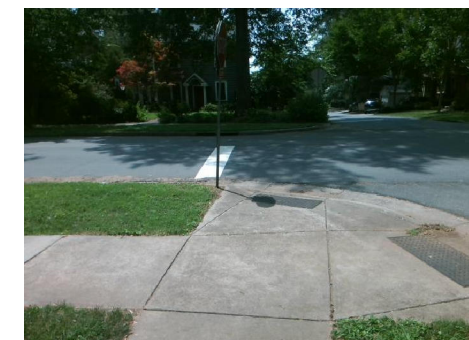
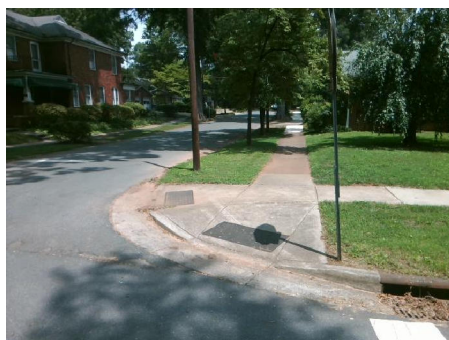
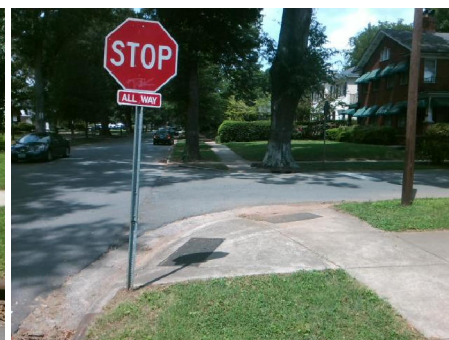
**Not Found, R304.2.2, R304.5.3**

Compliance	Description	Data	Compliance	Description	Data
N/A	Ramp Length (in)	67.0	No	Ramp Slope (%)	8.5
Yes	Ramp Width (in)	48.0	No	Ramp XSlope (%)	2.6
N/A	Flare Type LT	N/A	N/A	Flare Type RT	N/A
N/A	Flare Slope LT (%)	N/A	N/A	Flare Slope RT (%)	N/A
N/A	Flare Traversable LT?	N/A	N/A	Flare Traversable RT?	N/A
N/A	Landing Length (in)	N/A	N/A	DWS Provided?	N/A
N/A	Landing Width (in)	N/A	N/A	DWS Contrast?	N/A
N/A	Landing Slope (%)	N/A	N/A	DWS Length (in)	N/A
N/A	Landing X Slope (%)	N/A	N/A	DWS Full Width?	N/A
N/A	Landing Curb? (Y/N)	N/A	N/A	DWS Offset (in)	N/A
N/A	Shared Landing?	N/A			
N/A	Gutter Ponding?	N/A	N/A	Gutter Slope (%)	N/A
N/A	Gutter Lip Ht (in)	N/A	N/A	Gutter X Slope (%)	N/A
N/A	Painted X Walk1?	No	N/A	Painted X Walk2?	N/A
	X Walk 1 Direction	To SE		X Walk 2 Direction	N/A
N/A	X Walk 1 Width (in)	N/A	N/A	X Walk 2 Width (in)	N/A
	X Walk 1 Slope (%)	1.6		X Walk 2 Slope (%)	N/A
	X Walk 1 X Slope (%)	1.8		X Walk 2 X Slope (%)	N/A

N/A	Ramp inside XWalk1?	N/A	N/A	Ramp inside XWalk2?	N/A
	Road Slope (%)	N/A	N/A	Clear Space?	N/A
	Road X Slope (%)	N/A	N/A	Clear Space to XWalk (in)	N/A
N/A	Any Obstructions?	N/A	N/A	Storm Grate/Utility Hazard?	N/A
	Obstruction Type			Storm Grate/Utility Type	
		N/A			N/A
		Yes		Surface Condition? (G/P)	Good

**Remove & Replace Entire Ramp.**
