# Access Compliance Report

## Public Rights-of-Way

### (Curb Ramps)

Intersection ID: 44706	Main Street: AUSTON_CROSSING_DR	Cross Street: REAMES_RD	Location: SE
ADA ID: E93669D250B5	Ramp Type: Para	Initial Pass/Fail: Fail	Overall Compliance: No
Severity Score: 22.5			
Codes/Mitigation Info/Possible Solution		Field Measurements/Component Compliance

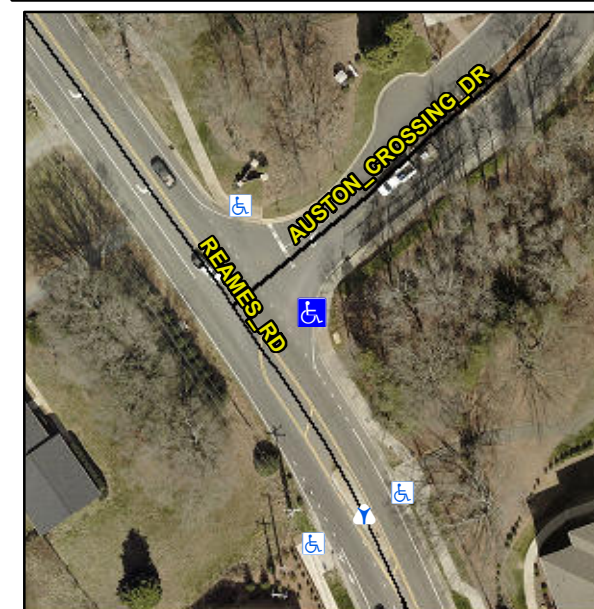
**RT RP < 5%**

**R304.5.1, R304.3.2, R304.5.3**

Compliance	Description	Data	Compliance	Description	Data
N/A	Ramp Length LT (in)	60.5	N/A	Ramp Length RT (in)	56.5
Yes	Ramp Width LT (in)	48.0	No	Ramp Width RT (in)	47.5
No	Ramp Slope LT (%)	8.9	Yes	Ramp Slope RT (%)	3.8
No	Ramp XSlope LT (%)	2.2	Yes	Ramp XSlope RT (%)	1.0
N/A	Landing Length (in)	N/A	N/A	DWS Provided?	N/A
N/A	Landing Width (in)	N/A	N/A	DWS Contrast?	N/A
N/A	Landing Slope (%)	N/A	N/A	DWS Length (in)	N/A
N/A	Landing X Slope (%)	N/A	N/A	DWS Full Width?	N/A
N/A	Landing Curb? (Y/N)	N/A	N/A	DWS Offset (in)	N/A
N/A	Shared Landing?	N/A			
N/A	Gutter Ponding?	N/A	N/A	Gutter Slope (%)	N/A
N/A	Gutter Lip Ht (in)	N/A	N/A	Gutter X Slope (%)	N/A
N/A	Painted X Walk1?	No	N/A	Painted X Walk2?	N/A
	X Walk 1 Direction	To N		X Walk 2 Direction	N/A
N/A	X Walk 1 Width (in)	N/A	N/A	X Walk 2 Width (in)	N/A
	X Walk 1 Slope (%)	2.5		X Walk 2 Slope (%)	N/A
	X Walk 1 X Slope (%)	1.3		X Walk 2 X Slope (%)	N/A
N/A	Ramp inside XWalk1?	N/A	N/A	Ramp inside XWalk2?	N/A

Road Slope (%)	N/A	N/A	Clear Space?	N/A
	Road X Slope (%)	N/A	N/A	Clear Space to XWalk (in)	N/A
N/A	Any Obstructions?	N/A	N/A	Storm Grate/Utility Hazard?	N/A
	Obstruction Type			Storm Grate/Utility Type	
		N/A			N/A
			Yes	Surface Condition? (G/P)	Good
			N/A	Curb Slope (%)	5.6

Possible Solutions:

**Remove & Replace Entire Ramp.**
