Intersection ID: 44730	Main Street: BENFIELD_RD	Cross Street: KOTLIK_DR	Location:	N
ADA ID: E9375BDFA75D	Ramp Type: Para	Initial Pass/Fail: Fail	Overall Compliance: No	Severity Score: 25

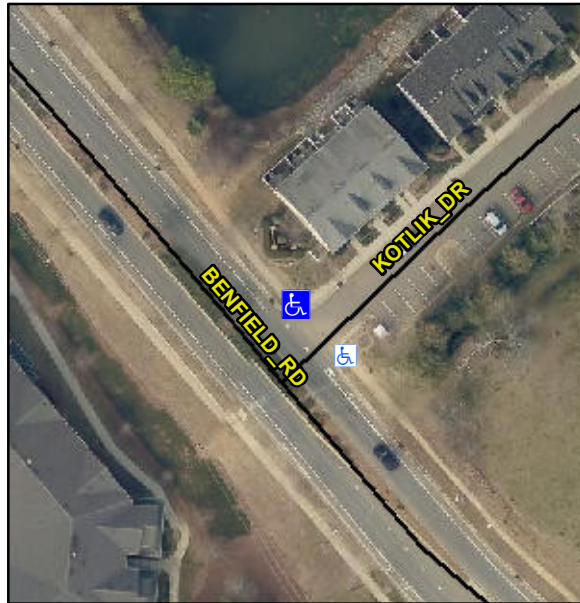
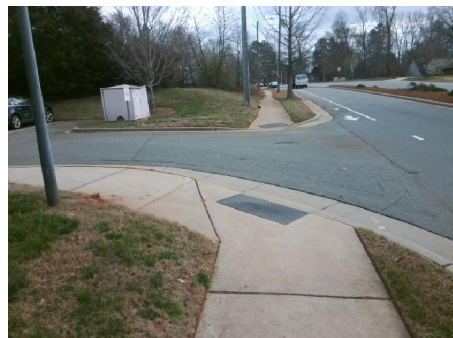
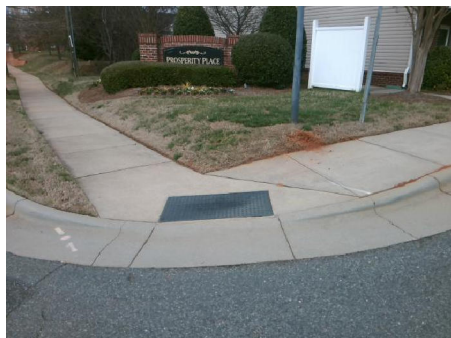
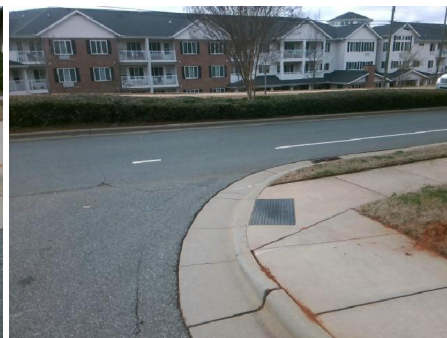
Compliance	Description	Data	Compliance	Description	Data
N/A	Ramp Length LT (in)	N/A	N/A	Ramp Length RT (in)	50.0
N/A	Ramp Width LT (in)	N/A	Yes	Ramp Width RT (in)	68.0
N/A	Ramp Slope LT (%)	N/A	No	Ramp Slope RT (%)	16.1
N/A	Ramp XSlope LT (%)	N/A	Yes	Ramp XSlope RT (%)	0.0
N/A	Landing Length (in)	N/A	N/A	DWS Provided?	N/A
N/A	Landing Width (in)	N/A	N/A	DWS Contrast?	N/A
N/A	Landing Slope (%)	N/A	N/A	DWS Length (in)	N/A
N/A	Landing X Slope (%)	N/A	N/A	DWS Full Width?	N/A
N/A	Landing Curb? (Y/N)	N/A	N/A	DWS Offset (in)	N/A
N/A	Shared Landing?	N/A			
N/A	Gutter Ponding?	N/A	N/A	Gutter Slope (%)	N/A
N/A	Gutter Lip Ht (in)	N/A	N/A	Gutter X Slope (%)	N/A
N/A	Painted X Walk1?	No	N/A	Painted X Walk2?	N/A
	X Walk 1 Direction	To SE		X Walk 2 Direction	N/A
N/A	X Walk 1 Width (in)	N/A	N/A	X Walk 2 Width (in)	N/A
	X Walk 1 Slope (%)	1.6		X Walk 2 Slope (%)	N/A
	X Walk 1 X Slope (%)	7.1		X Walk 2 X Slope (%)	N/A
N/A	Ramp inside XWalk1?	N/A	N/A	Ramp inside XWalk2?	N/A

Road Slope (%)	N/A	N/A	Clear Space?	N/A
	Road X Slope (%)	N/A	N/A	Clear Space to XWalk (in)	N/A
N/A	Any Obstructions?	N/A	N/A	Storm Grate/Utility Hazard?	N/A
	Obstruction Type			Storm Grate/Utility Type	
		N/A			N/A
			Yes	Surface Condition? (G/P)	Good
			N/A	Curb Slope (%)	15.9

### Remove & Replace Entire Ramp.
