Access Compliance Report

Public Rights-of-Way

(Curb Ramps)

Intersection ID: 13877	Main Street: MYRTLE_AV	Cross Street: TEMPLETON_AV	Location: W
ADA ID: E93CEA0F2C56	Ramp Type: Directional1	Initial Pass/Fail: Fail	Overall Compliance: No
		Severity Score: 25

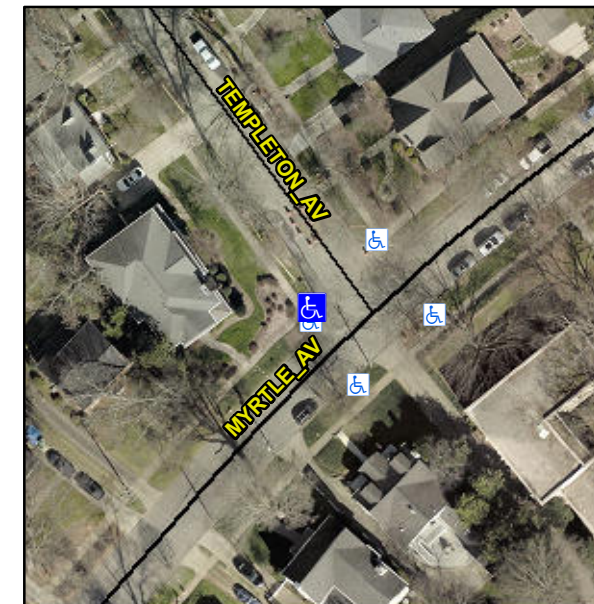
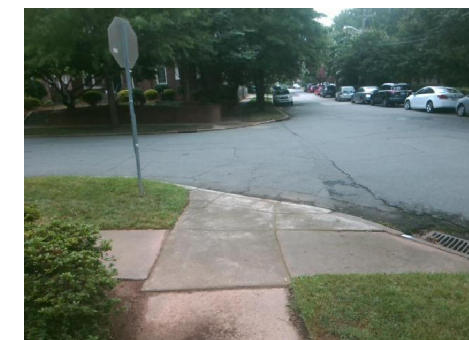
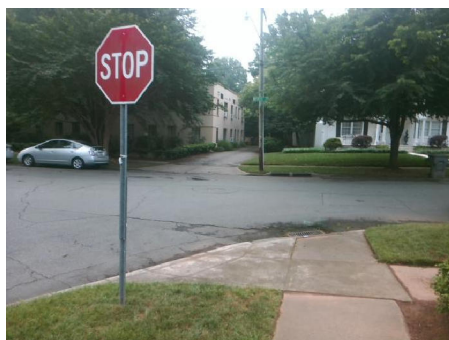
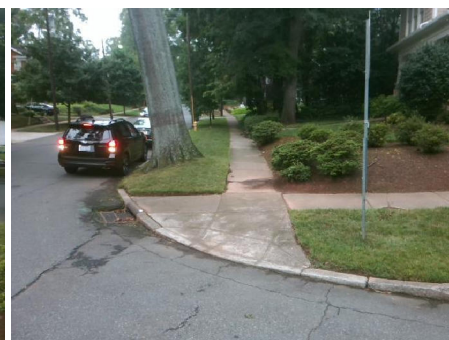
Compliance	Description	Data	Compliance	Description	Data
N/A	Ramp Length (in)	54.0	N/A	Grade Break?	N/A
Yes	Ramp Width (in)	48.0	N/A	Grade Break Slope (%)	0.0
Yes	Ramp Slope (%)	6.4	N/A	Grade Break XSlope (%)	0.0
No	Ramp XSlope (%)	7.3			
N/A	Flare Type LT	N/A	N/A	Flare Type RT	N/A
N/A	Flare Slope LT (%)	N/A	N/A	Flare Slope RT (%)	0.0
N/A	Flare Traversable LT?	N/A	N/A	Flare Traversable RT?	N/A
N/A	Landing Length (in)	0.0	N/A	DWS Provided?	N/A
N/A	Landing Width (in)	0.0	N/A	DWS Contrast?	N/A
N/A	Landing Slope (%)	0.0	N/A	DWS Length (in)	N/A
N/A	Landing X Slope (%)	0.0	N/A	DWS Full Width?	N/A
N/A	Landing Curb? (Y/N)	N/A	N/A	DWS Offset LT (in)	N/A
N/A	Shared Landing?	N/A	N/A	DWS Offset RT (in)	N/A
N/A	Gutter Ponding?	0.0	N/A	Gutter Slope (%)	N/A
N/A	Gutter Lip Ht (in)	1.0	N/A	Gutter X Slope (%)	N/A
N/A	Painted X Walk1?	No		Road Slope (%)	6.4
	X Walk 1 Direction	To NE		Road X Slope (%)	1.2
	X Walk 1 Width (in)	N/A		Clear Space?	N/A

X Walk 1 Slope (%)	6.4	N/A	Clear Space to XWalk (in)	N/A
	X Walk 1 X Slope (%)	1.2	N/A	Storm Grate/Utility Hazard?	N/A
N/A	Ramp inside XWalk1?	N/A		Storm Grate/Utility Type	
N/A	Any Obstructions?	N/A			N/A
	Obstruction Type		Yes	Surface Condition? (G/P)	Good
			N/A	Curb Slope (%)	9.6

Remove & Replace Entire Ramp.

R304.5.3
