Access Compliance Report Public Rights-of-Way (Curb Ramps)

Location	NW
Intersection ID: 13494	Main Street: HAMORY_DR			Cross Street: VERNEDALE_RD				Location:	
ADA ID: E93DC07AA100	0: E93DC07AA100 Ramp Type: PerpDiag			Initial Pass/Fail: Fail Overall Compliance: No				o Severity Score:	21.25
Codes/Mitigation Info/Possible Solution				Field Measurements/Component Compliance					
		Possible Solutions:		Compliance Description Data			Compliance Description		Data
		Remove & Replace Curb Ramp V	Vith	N/A	Ramp Length (in)	86.5	No	Ramp Slope (%)	8.5
		Two New Directional Ramps or		No	Ramp Width (in)	47.0	Yes	Ramp XSlope (%)	0.5
		Equivalent.		N/A	Flare Type LT	N/A	N/A	Flare Type RT	N/A
				N/A	Flare Slope LT (%)	N/A	N/A	Flare Slope RT (%)	N/A
				N/A	Flare Traversable LT?	N/A	N/A	Flare Traversable RT?	N/A
				N/A	Landing Length (in)	N/A	N/A	DWS Provided?	N/A
	The MUSSIBLE	Surveyor Notes:		N/A	Landing Width (in)	N/A	N/A	DWS Contrast?	N/A
K A A A A A A A A A A A A A A A A A A A		N/A		N/A	Landing Slope (%)	N/A	N/A	DWS Length (in)	N/A

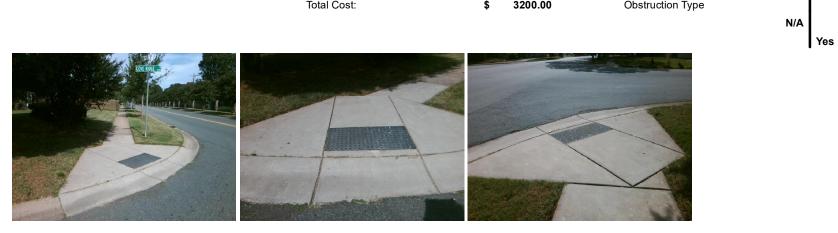
au a			N/A	Landing X Slope (%)	N/A	N/A	DWS Full Width?	N/A
			N/A	Landing Curb? (Y/N)	N/A	N/A	DWS Offset (in)	N/A	
			N/A	Shared Landing?	N/A				
	. F	PROW/ADA:		N/A	Gutter Ponding?	N/A	N/A	Gutter Slope (%)	N/A
State of the second sec	and the second	Not Found, R304.5.1, R304.2.2		N/A	Gutter Lip Ht (in)	N/A	N/A	Gutter X Slope (%)	N/A
Contraction of the second s				N/A	Painted X Walk1?	No	N/A	Painted X Walk2?	No
Sal P / State				X Walk 1 Direction	To SE		X Walk 2 Direction	To E	
				N/A	X Walk 1 Width (in)	N/A	N/A	X Walk 2 Width (in)	N/A
Street 1 Name	COVE RIDGE LN	_			X Walk 1 Slope (%)	2.2		X Walk 2 Slope (%)	3.0
Stop Condition-Street 2	StopSign				X Walk 1 X Slope (%)	0.9		X Walk 2 X Slope (%)	0.3
Street 2 Name	VERNEDALE RD			N/A	Ramp inside XWalk1?	N/A	N/A	Ramp inside XWalk2?	N/A
Stop Condition-Street 1	None				Road Slope (%)	0.2	N/A	Clear Space?	N/A
					Road X Slope (%)	0.2	N/A	Clear Space to XWalk (in)	N/A

N/A	Any Obstructions?	N/A	N/A	Storm Grate/Utility Hazard?	N/A
		Total Cost: \$ 3	200.00		Obstruction Type			Storm Grate/Utility Type	
						N/A			N/A
