Access Compliance Report Public Rights-of-Way (Curb Ramps)

| Intersection ID: 13673 | ction ID: 13673 Main Street: CENTRAL_AV | | | | | Location: | SW | | | |
| | | | | Cross Street: CRYSTAL_RD | | | | | | |
| ADA ID: E9513AE29A6F Ramp Type: Perp | | | Initial Pass/Fail: Fail Overall Compliance: No | | | | | o Severity Score: | 31.25 | |

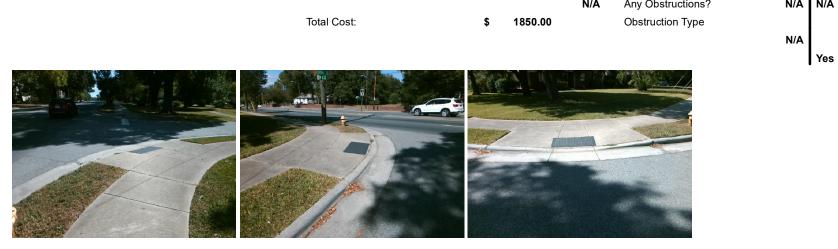
| Intersection ID: 13673 | ction ID: 13673 Main Street: CENTRAL_AV | | | | | Location: | SW | | | |
|---|---|---|--|---|---|---|---|---|---|--|
| | - | Remove & Replace Entire Ramp | . । | N/A | Ramp Length (in) | 47.0 | No | Ramp Slope (%) | 8.7 | |
| | THE PASS | | | No | Ramp Width (in) | 34.0 | No | Ramp XSlope (%) | 3.8 | |

| Intersection ID: 13673 | ction ID: 13673 Main Street: CENTRAL_AV | | | | | Location: | SW | | | |
|---|---|---|--|---|---|---|---|---|---|--|
| | | Total Cost: \$ | 1850.00 | | Obstruction Type | | | Storm Grate/Utility Type | | |
