Access Compliance Report

Public Rights-of-Way

(Curb Ramps)

Intersection ID: 11672	Main Street: CARTWRIGHT_PL	Cross Street: KEMPTON_PL	Location: SW
ADA ID: E9525D17F81B	Ramp Type: Perp	Initial Pass/Fail: Fail	Overall Compliance: No
			Severity Score: 21.25

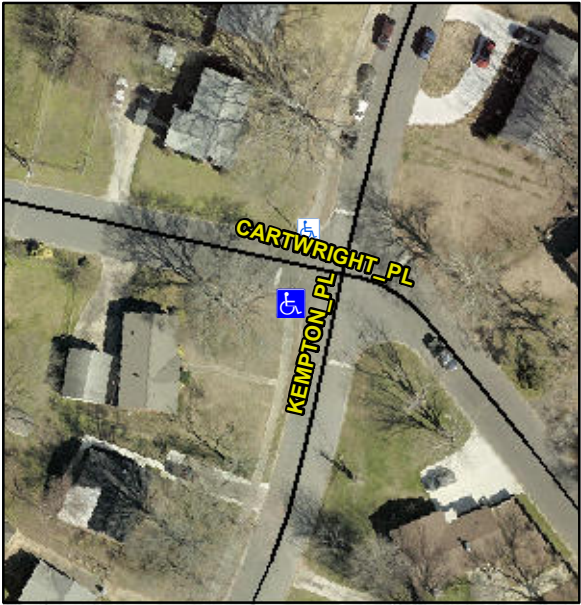
Possible Solutions:		Compliance	Description	Data
	Remove & Replace Entire Ramp.		N/A	Ramp Length (in)	48.5
			No	Ramp Width (in)	47.5
			N/A	Flare Type LT	N/A
			N/A	Flare Slope LT (%)	N/A
			N/A	Flare Traversable LT?	N/A
			N/A	Landing Length (in)	N/A
			N/A	Landing Width (in)	N/A
			N/A	Landing Slope (%)	N/A
			N/A	Landing X Slope (%)	N/A
<p>Surveyor Notes:</p> <p>N/A</p> <p>PROW/ADA:</p> <p>Not Found, R304.5.1, R304.5.3</p>			N/A	Flare Type RT	N/A
			N/A	Flare Slope RT (%)	N/A
			N/A	Flare Traversable RT?	N/A
			N/A	DWS Provided?	N/A
			N/A	DWS Contrast?	N/A
			N/A	DWS Length (in)	N/A
			N/A	DWS Full Width?	N/A
			N/A	DWS Offset (in)	N/A
			N/A	Shared Landing?	N/A
			N/A	Gutter Ponding?	N/A
			N/A	Gutter Lip Ht (in)	N/A
			N/A	Painted X Walk1?	No
				X Walk 1 Direction	To NW
			N/A	X Walk 1 Width (in)	N/A
				X Walk 1 Slope (%)	2.5

X Walk 1 X Slope (%)	3.4
			N/A	Ramp inside XWalk1?	N/A
			N/A	Road Slope (%)	N/A
			N/A	Road X Slope (%)	N/A
			N/A	Any Obstructions?	N/A
				Obstruction Type	
			N/A		
			N/A		N/A
			Yes	Surface Condition? (G/P)	Good
Total Cost:		\$ 1850.00
