# Access Compliance Report

## Public Rights-of-Way

### (Curb Ramps)

Intersection ID: 48435	Main Street: BEDLINGTON_RD	Cross Street: SEAMILL_RD	Location: SW
ADA ID: E95B4929A656	Ramp Type: Perp	Initial Pass/Fail: Fail	Overall Compliance: No
Severity Score: 13.75			
Codes/Mitigation Info/Possible Solution		Field Measurements/Component Compliance

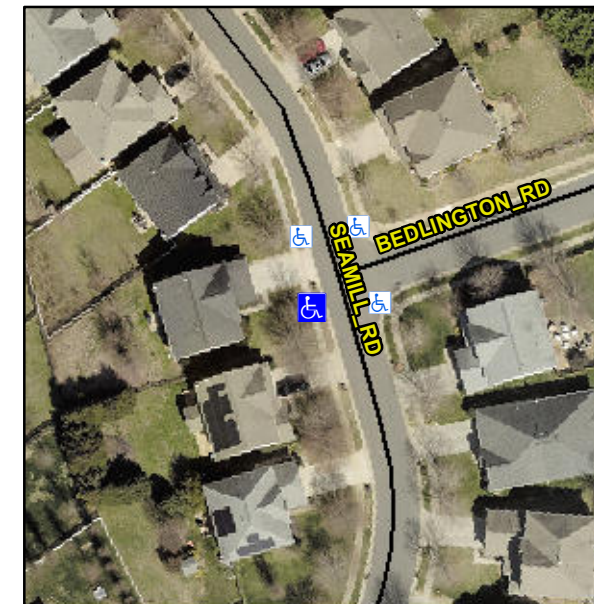
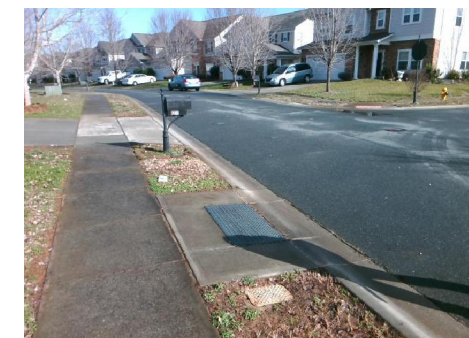
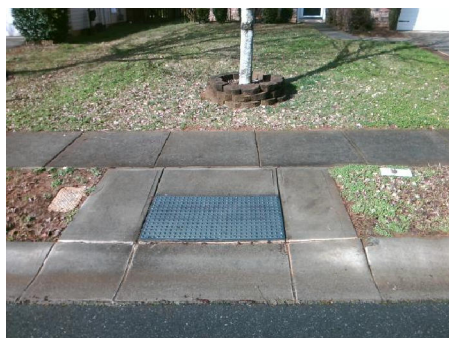
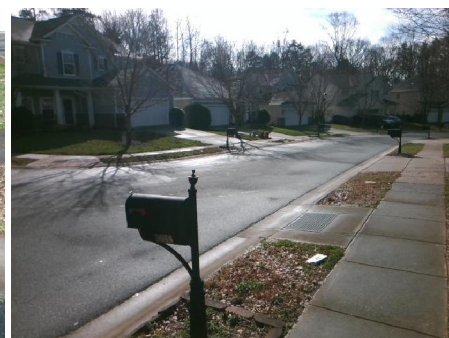
Compliance	Description	Data	Compliance	Description	Data
N/A	Ramp Length (in)	48.0	No	Ramp Slope (%)	10.7
Yes	Ramp Width (in)	49.0	No	Ramp XSlope (%)	3.7
N/A	Flare Type LT	N/A	N/A	Flare Type RT	N/A
N/A	Flare Slope LT (%)	N/A	N/A	Flare Slope RT (%)	N/A
N/A	Flare Traversable LT?	N/A	N/A	Flare Traversable RT?	N/A
N/A	Landing Length (in)	N/A	N/A	DWS Provided?	N/A
N/A	Landing Width (in)	N/A	N/A	DWS Contrast?	N/A
N/A	Landing Slope (%)	N/A	N/A	DWS Length (in)	N/A
N/A	Landing X Slope (%)	N/A	N/A	DWS Full Width?	N/A
N/A	Landing Curb? (Y/N)	N/A	N/A	DWS Offset (in)	N/A
N/A	Shared Landing?	N/A			
N/A	Gutter Ponding?	N/A	N/A	Gutter Slope (%)	N/A
N/A	Gutter Lip Ht (in)	N/A	N/A	Gutter X Slope (%)	N/A
N/A	Painted X Walk1?	No	N/A	Painted X Walk2?	N/A
	X Walk 1 Direction	To E		X Walk 2 Direction	N/A
N/A	X Walk 1 Width (in)	N/A	N/A	X Walk 2 Width (in)	N/A
	X Walk 1 Slope (%)	3.0		X Walk 2 Slope (%)	N/A
	X Walk 1 X Slope (%)	3.5		X Walk 2 X Slope (%)	N/A

N/A	Ramp inside XWalk1?	N/A	N/A	Ramp inside XWalk2?	N/A
	Road Slope (%)	N/A	N/A	Clear Space?	N/A
	Road X Slope (%)	N/A	N/A	Clear Space to XWalk (in)	N/A
N/A	Any Obstructions?	N/A	N/A	Storm Grate/Utility Hazard?	N/A
	Obstruction Type			Storm Grate/Utility Type	
		N/A			N/A
		Yes		Surface Condition? (G/P)	Good

**Remove & Replace Entire Ramp.**

**R304.2.2, R304.5.3**

Total Cost: \$ 1850.00
