# Access Compliance Report

## Public Rights-of-Way

### (Curb Ramps)

Intersection ID: 26209	Main Street: CARMEL_RD	Cross Street: JOHNSTON_RD	Location: NW
ADA ID: E95BE5B20B8E	Ramp Type: Perp	Initial Pass/Fail: Fail	Overall Compliance: No
Severity Score: 33.75			
Codes/Mitigation Info/Possible Solution		Field Measurements/Component Compliance

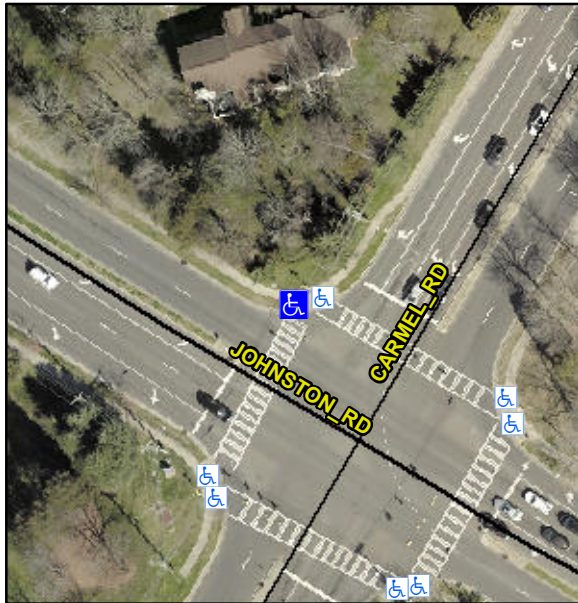
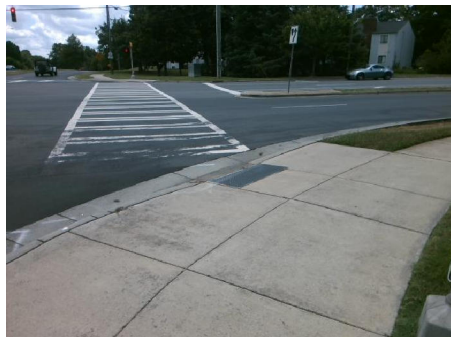
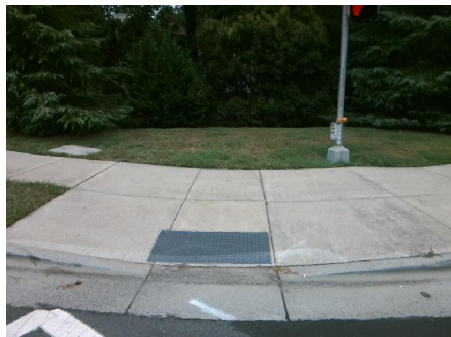
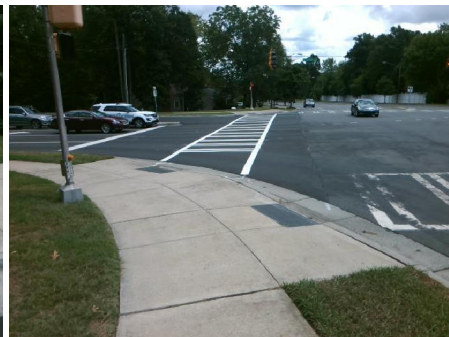
**R304.5.1, R304.2.2, R304.5.3**

Compliance	Description	Data	Compliance	Description	Data
N/A	Ramp Length (in)	60.0	No	Ramp Slope (%)	9.0
No	Ramp Width (in)	44.0	No	Ramp XSlope (%)	5.9
N/A	Flare Type LT	N/A	N/A	Flare Type RT	N/A
N/A	Flare Slope LT (%)	N/A	N/A	Flare Slope RT (%)	N/A
N/A	Flare Traversable LT?	N/A	N/A	Flare Traversable RT?	N/A
N/A	Landing Length (in)	N/A	N/A	DWS Provided?	N/A
N/A	Landing Width (in)	N/A	N/A	DWS Contrast?	N/A
N/A	Landing Slope (%)	N/A	N/A	DWS Length (in)	N/A
N/A	Landing X Slope (%)	N/A	N/A	DWS Full Width?	N/A
N/A	Landing Curb? (Y/N)	N/A	N/A	DWS Offset (in)	N/A
N/A	Shared Landing?	N/A			
N/A	Gutter Ponding?	N/A	N/A	Gutter Slope (%)	N/A
N/A	Gutter Lip Ht (in)	N/A	N/A	Gutter X Slope (%)	N/A
N/A	Painted X Walk1?	Yes	N/A	Painted X Walk2?	N/A
	X Walk 1 Direction	To SW		X Walk 2 Direction	N/A
N/A	X Walk 1 Width (in)	132.0	N/A	X Walk 2 Width (in)	N/A
	X Walk 1 Slope (%)	4.3		X Walk 2 Slope (%)	N/A
	X Walk 1 X Slope (%)	2.5		X Walk 2 X Slope (%)	N/A

N/A	Ramp inside XWalk1?	Yes	N/A	Ramp inside XWalk2?	N/A
	Road Slope (%)	N/A	N/A	Clear Space?	N/A
	Road X Slope (%)	N/A	N/A	Clear Space to XWalk (in)	N/A
N/A	Any Obstructions?	N/A	N/A	Storm Grate/Utility Hazard?	N/A
	Obstruction Type			Storm Grate/Utility Type	
		N/A			N/A
		Yes		Surface Condition? (G/P)	Good

**Remove & Replace Entire Ramp.**
