Access Compliance Report

Public Rights-of-Way

(Curb Ramps)

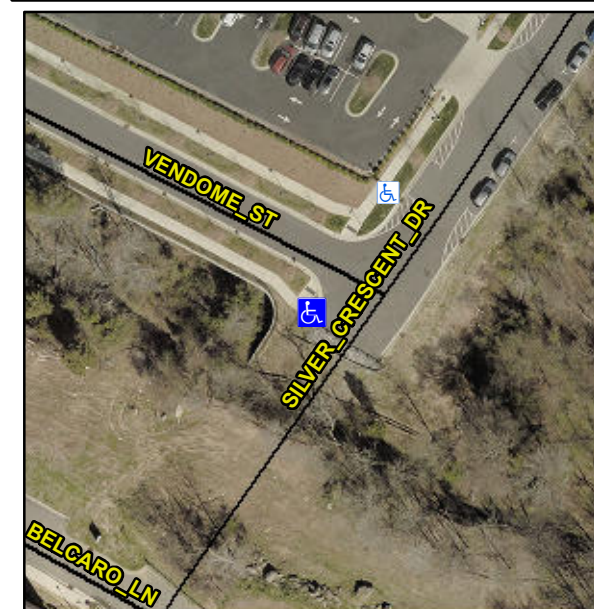
Intersection ID: 44778	Main Street: SILVER_CRESCENT_DR	Cross Street: VENDOME_ST	Location: SW
ADA ID: E95FE5E1E17E	Ramp Type: Directional1	Initial Pass/Fail: Fail	Overall Compliance: No
Severity Score: 12.5			
Codes/Mitigation Info/Possible Solution		Field Measurements/Component Compliance

Compliance	Description	Data	Compliance	Description	Data
N/A	Ramp Length (in)	90.0	N/A	Grade Break?	N/A
Yes	Ramp Width (in)	70.0	N/A	Grade Break Slope (%)	0.0
Yes	Ramp Slope (%)	4.0	N/A	Grade Break XSlope (%)	0.0
No	Ramp XSlope (%)	6.3			
N/A	Flare Type LT	N/A	N/A	Flare Type RT	N/A
N/A	Flare Slope LT (%)	N/A	N/A	Flare Slope RT (%)	0.0
N/A	Flare Traversable LT?	N/A	N/A	Flare Traversable RT?	N/A
N/A	Landing Length (in)	0.0	N/A	DWS Provided?	N/A
N/A	Landing Width (in)	0.0	N/A	DWS Contrast?	N/A
N/A	Landing Slope (%)	0.0	N/A	DWS Length (in)	N/A
N/A	Landing X Slope (%)	0.0	N/A	DWS Full Width?	N/A
N/A	Landing Curb? (Y/N)	N/A	N/A	DWS Offset LT (in)	N/A
N/A	Shared Landing?	N/A	N/A	DWS Offset RT (in)	N/A
N/A	Gutter Ponding?	0.0	N/A	Gutter Slope (%)	N/A
N/A	Gutter Lip Ht (in)	0.0	N/A	Gutter X Slope (%)	N/A
N/A	Painted X Walk1?	No		Road Slope (%)	3.9
	X Walk 1 Direction	To NE		Road X Slope (%)	1.4
	X Walk 1 Width (in)	N/A		Clear Space?	N/A

X Walk 1 Slope (%)	3.9	N/A	Clear Space to XWalk (in)	N/A
	X Walk 1 X Slope (%)	1.4	N/A	Storm Grate/Utility Hazard?	N/A
N/A	Ramp inside XWalk1?	N/A		Storm Grate/Utility Type	
N/A	Any Obstructions?	N/A			N/A
	Obstruction Type		Yes	Surface Condition? (G/P)	Good
			N/A	Curb Slope (%)	1.2

Possible Solutions:

Remove & Replace Entire Ramp.

R304.5.3

\$ 1600.00
