Access Compliance Report

Public Rights-of-Way

(Curb Ramps)

Intersection ID: 52716	Main Street: AGAVA_LN	Cross Street: MAIDENHAIR_CT	Location: NE
ADA ID: E964F2A78503	Ramp Type: Perp	Initial Pass/Fail: Fail	Overall Compliance: No
Codes/Mitigation Info/Possible Solution		Field Measurements/Component Compliance	
Severity Score: 13.75

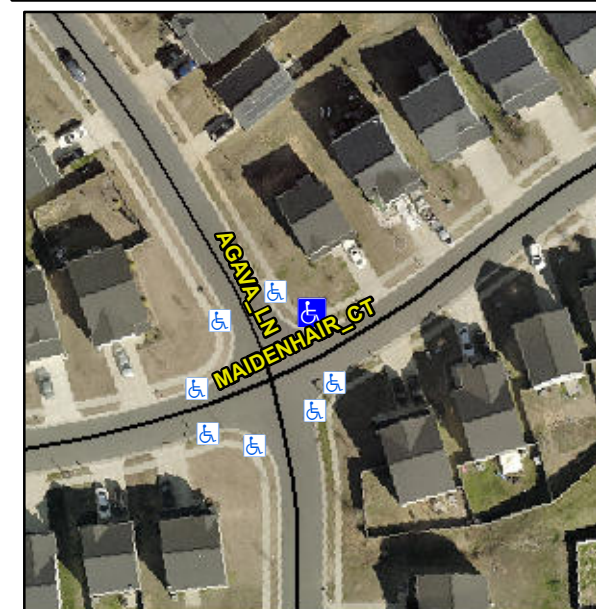
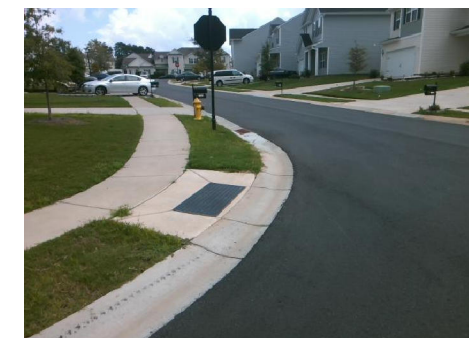
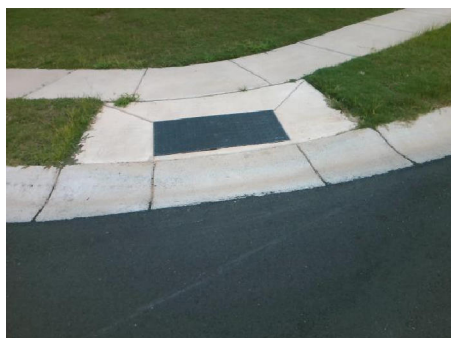
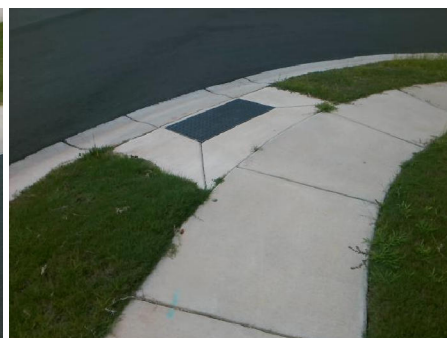
Not Found, R304.2.2, R304.5.3

Compliance	Description	Data	Compliance	Description	Data
N/A	Ramp Length (in)	46.0	No	Ramp Slope (%)	8.4
Yes	Ramp Width (in)	48.0	No	Ramp XSlope (%)	4.2
N/A	Flare Type LT	N/A	N/A	Flare Type RT	N/A
N/A	Flare Slope LT (%)	N/A	N/A	Flare Slope RT (%)	N/A
N/A	Flare Traversable LT?	N/A	N/A	Flare Traversable RT?	N/A
N/A	Landing Length (in)	N/A	N/A	DWS Provided?	N/A
N/A	Landing Width (in)	N/A	N/A	DWS Contrast?	N/A
N/A	Landing Slope (%)	N/A	N/A	DWS Length (in)	N/A
N/A	Landing X Slope (%)	N/A	N/A	DWS Full Width?	N/A
N/A	Landing Curb? (Y/N)	N/A	N/A	DWS Offset (in)	N/A
N/A	Shared Landing?	N/A			
N/A	Gutter Ponding?	N/A	N/A	Gutter Slope (%)	N/A
N/A	Gutter Lip Ht (in)	N/A	N/A	Gutter X Slope (%)	N/A
N/A	Painted X Walk1?	No	N/A	Painted X Walk2?	N/A
	X Walk 1 Direction	To S		X Walk 2 Direction	N/A
N/A	X Walk 1 Width (in)	N/A	N/A	X Walk 2 Width (in)	N/A
	X Walk 1 Slope (%)	3.1		X Walk 2 Slope (%)	N/A
	X Walk 1 X Slope (%)	2.9		X Walk 2 X Slope (%)	N/A

N/A	Ramp inside XWalk1?	N/A	N/A	Ramp inside XWalk2?	N/A
	Road Slope (%)	N/A	N/A	Clear Space?	N/A
	Road X Slope (%)	N/A	N/A	Clear Space to XWalk (in)	N/A
N/A	Any Obstructions?	N/A	N/A	Storm Grate/Utility Hazard?	N/A
	Obstruction Type			Storm Grate/Utility Type	
		N/A			N/A
			Yes	Surface Condition? (G/P)	Good

Possible Solutions:

Remove & Replace Entire Ramp.
