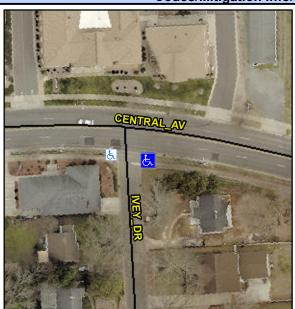
Intersection ID: 13324Main Street: CENTRAL_AVCross Street: IVEY_DRLocation:SEADA ID: E98C4961EEC0Ramp Type: PerpInitial Pass/Fail: FailOverall Compliance: NoSeverity Score:60

Field Measurements/Component Compliance							
Comp	Compliance Description		Comp	liance Description	ion Data		
N/A	Ramp Length (in)	72.0	Yes	Ramp Slope (%)	6.7		
No	Ramp Width (in)	28.0	No	Ramp XSlope (%)	10.8		
N/A	Flare Type LT	N/A	N/A	Flare Type RT	N/A		
N/A	Flare Slope LT (%)	N/A	N/A	Flare Slope RT (%)	N/A		
N/A	Flare Traversable LT?	N/A	N/A	Flare Traversable RT?	N/A		
N/A	Landing Length (in)	N/A	N/A	DWS Provided?	N/A		
N/A	Landing Width (in)	N/A	N/A	DWS Contrast?	N/A		
N/A	Landing Slope (%)	N/A	N/A	DWS Length (in)	N/A		
N/A	Landing X Slope (%)	N/A	N/A	DWS Full Width?	N/A		
N/A	Landing Curb? (Y/N)	N/A	N/A	DWS Offset (in)	N/A		
N/A	Shared Landing?	N/A					
N/A	Gutter Ponding?	N/A	N/A	Gutter Slope (%)	N/A		
N/A	Gutter Lip Ht (in)	N/A	N/A	Gutter X Slope (%)	N/A		
N/A	Painted X Walk1?	No	N/A	Painted X Walk2?	N/A		
	X Walk 1 Direction	To NW		X Walk 2 Direction	N/A		
N/A	X Walk 1 Width (in)	N/A	N/A	X Walk 2 Width (in)	N/A

X Walk 1 Slope (%)	7.0		X Walk 2 Slope (%)	N/A		
	X Walk 1 X Slope (%)	3.0		X Walk 2 X Slope (%)	N/A		
N/A	Ramp inside XWalk1?	N/A	N/A	Ramp inside XWalk2?	N/A		
	Road Slope (%)	N/A	N/A	Clear Space?	N/A		
	Road X Slope (%)	N/A	N/A	Clear Space to XWalk (in)	N/A		
N/A	Any Obstructions?	N/A	N/A	Storm Grate/Utility Hazard?	N/A		
	Obstruction Type			Storm Grate/Utility Type			
		N/A			N/A		
			Yes	Surface Condition? (G/P)	Good

Possible Solutions:	С
	Remove & Replace Entire Ramp.	N
	•	N
		N
l		N
		N
		N
	Surveyor Notes:	N
ì	N/A	N
		N
-		N
The second		N
100	PROW/ADA:	N
	Not Found, R304.5.1, R304.5.3	N
		N
100		
		N
		N
