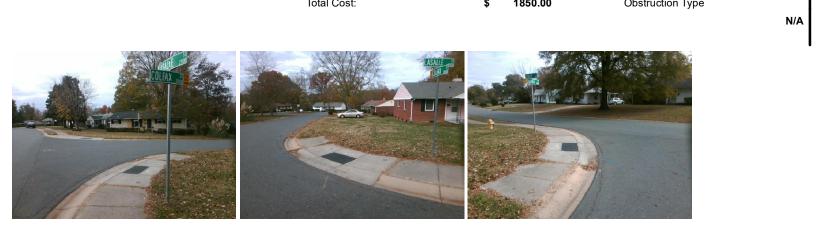
Intersection ID: 8558	Main St	Cross Street: LASALLE_ST				Location:	Ν			
ADA ID: E98F87A025A8	DA ID: E98F87A025A8 Ramp Type: Perp		Initial Pass/Fail: Fail Overall Compliance: N				ICE: N	o Severity Score:	8.75	
Codes/Mitigation Info/Possible Solution				Field Measurements/Component Compliance						
	11/	Possible Solutions:	Compliance Description			Data Compliance Description			Data	
The Part of the second		Remove & Replace Entire Ramp		N/A	Ramp Length (in)	56.0	Yes	Ramp Slope (%)	6.6	
CARE AND TO I DI	1			No	Ramp Width (in)	47.0	Yes	Ramp XSlope (%)	1.0	
Site The Martin State	An			N/A	Flare Type LT	N/A	N/A	Flare Type RT	N/A	
A A A A A	An and			N/A	Flare Slope LT (%)	N/A	N/A	Flare Slope RT (%)	N/A	
				N/A	Flare Traversable LT?	N/A	N/A	Flare Traversable RT?	N/A	
				N/A	Landing Length (in)	N/A	N/A	DWS Provided?	N/A	
COLFAX OF L.S	× ;	Surveyor Notes:		N/A	Landing Width (in)	N/A	N/A	DWS Contrast?	N/A	
	R.M	N/A		N/A	Landing Slope (%)	N/A	N/A	DWS Length (in)	N/A

7 10			N/A	Landing X Slope (%)	N/A	N/A	DWS Full Width?	N/A	
A CARLEN /	1 miles			N/A	Landing Curb? (Y/N)	N/A	N/A	DWS Offset (in)	N/A	
	- Prit			N/A	Shared Landing?	N/A				
	A 1784	PROW/ADA:		N/A	Gutter Ponding?	N/A	N/A	Gutter Slope (%)	N/A	
		Not Found, R304.5.1		N/A	Gutter Lip Ht (in)	N/A	N/A	Gutter X Slope (%)	N/A	
				N/A	Painted X Walk1?	No	N/A	Painted X Walk2?	N/A	
					X Walk 1 Direction	To SW		X Walk 2 Direction	N/A	
				N/A	X Walk 1 Width (in)	N/A	N/A	X Walk 2 Width (in)	N/A	
Street 1 Name	COLFAX ST	_			X Walk 1 Slope (%)	0.3		X Walk 2 Slope (%)	N/A	
Stop Condition-Street 2	StopSign				X Walk 1 X Slope (%)	3.5		X Walk 2 X Slope (%)	N/A	
Street 2 Name	N/A			N/A	Ramp inside XWalk1?	N/A	N/A	Ramp inside XWalk2?	N/A	
Stop Condition-Street 1	N/A				Road Slope (%)	N/A	N/A	Clear Space?	N/A	
					Road X Slope (%)	N/A	N/A	Clear Space to XWalk (in)	N/A	
				N/A	Any Obstructions?	N/A	N/A	Storm Grate/Utility Hazard?	N/A

Total Cost: \$	1850.00		Obstruction Type			Storm Grate/Utility Type		
						N/A			N/A
