Access Compliance Report

Public Rights-of-Way

(Curb Ramps)

Intersection ID: 49397	Main Street: HERFORD_ST	Cross Street: DAMASCUS_ST	Location: NW
ADA ID: E9983FFBCD2D	Ramp Type: PerpDiag	Initial Pass/Fail: Fail	Overall Compliance: No
		Severity Score: 12.5

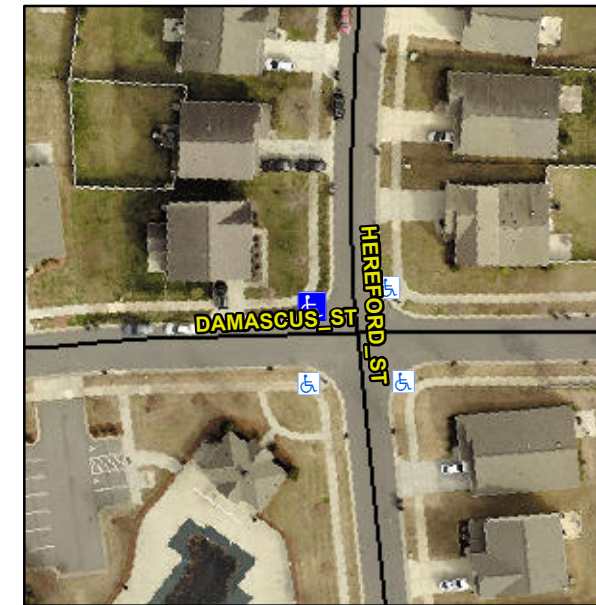
Not Found, R304.5.3

Compliance	Description	Data	Compliance	Description	Data
N/A	Ramp Length (in)	72.0	Yes	Ramp Slope (%)	5.4
Yes	Ramp Width (in)	48.0	No	Ramp XSlope (%)	6.4
N/A	Flare Type LT	N/A	N/A	Flare Type RT	N/A
N/A	Flare Slope LT (%)	N/A	N/A	Flare Slope RT (%)	N/A
N/A	Flare Traversable LT?	N/A	N/A	Flare Traversable RT?	N/A
N/A	Landing Length (in)	N/A	N/A	DWS Provided?	N/A
N/A	Landing Width (in)	N/A	N/A	DWS Contrast?	N/A
N/A	Landing Slope (%)	N/A	N/A	DWS Length (in)	N/A
N/A	Landing X Slope (%)	N/A	N/A	DWS Full Width?	N/A
N/A	Landing Curb? (Y/N)	N/A	N/A	DWS Offset (in)	N/A
N/A	Shared Landing?	N/A			
N/A	Gutter Ponding?	N/A	N/A	Gutter Slope (%)	N/A
N/A	Gutter Lip Ht (in)	N/A	N/A	Gutter X Slope (%)	N/A
N/A	Painted X Walk1?	No	N/A	Painted X Walk2?	No
	X Walk 1 Direction	To S		X Walk 2 Direction	To E
N/A	X Walk 1 Width (in)	N/A	N/A	X Walk 2 Width (in)	N/A
	X Walk 1 Slope (%)	2.3		X Walk 2 Slope (%)	0.7
	X Walk 1 X Slope (%)	0.5		X Walk 2 X Slope (%)	3.8

N/A	Ramp inside XWalk1?	N/A	N/A	Ramp inside XWalk2?	N/A
	Road Slope (%)	4.4	N/A	Clear Space?	N/A
	Road X Slope (%)	2.5	N/A	Clear Space to XWalk (in)	N/A
N/A	Any Obstructions?	N/A	N/A	Storm Grate/Utility Hazard?	N/A
	Obstruction Type			Storm Grate/Utility Type	
		N/A			N/A
		Yes		Surface Condition? (G/P)	Good

Remove & Replace Curb Ramp With Two New Directional Ramps or Equivalent.
