Access Compliance Report

Public Rights-of-Way

(Curb Ramps)

Intersection ID: 7952	Main Street: JULIA_AV	Cross Street: CARMINE_ST	Location: SW
ADA ID: E9A354A8C3B7	Ramp Type: PerpDiag	Initial Pass/Fail: Fail	Overall Compliance: No
Severity Score: 21.25			
Codes/Mitigation Info/Possible Solution		Field Measurements/Component Compliance

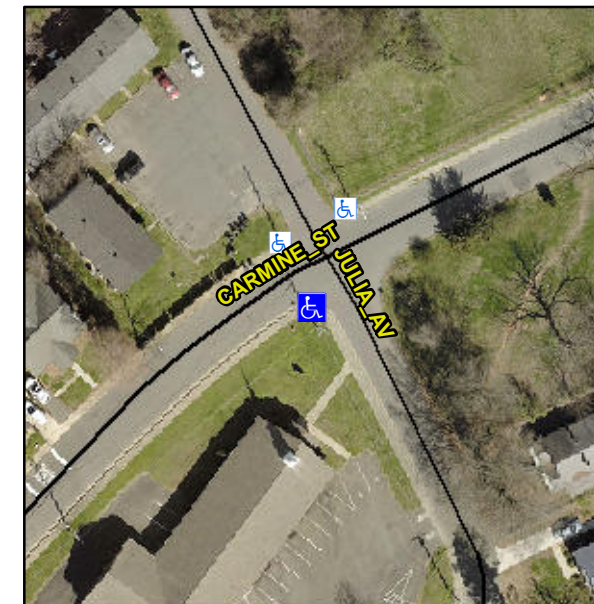
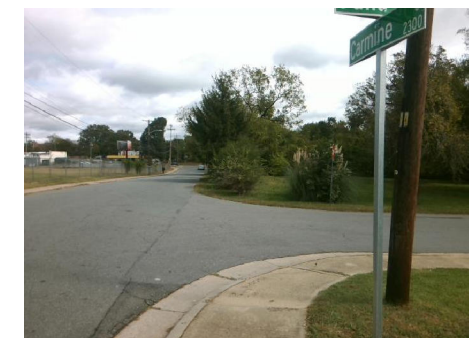
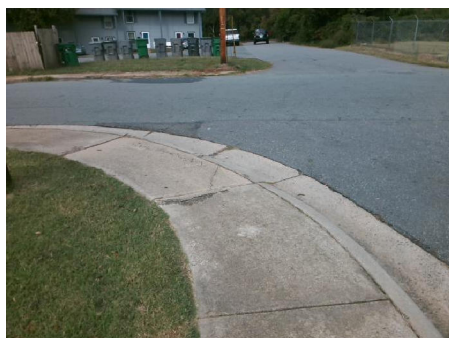
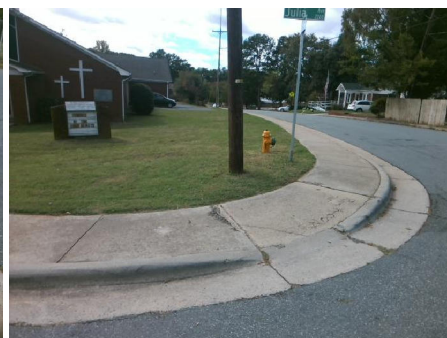
Not Found, R304.5.1, R304.2.2

Compliance	Description	Data	Compliance	Description	Data
N/A	Ramp Length (in)	48.0	No	Ramp Slope (%)	9.6
No	Ramp Width (in)	46.0	Yes	Ramp XSlope (%)	1.7
N/A	Flare Type LT	N/A	N/A	Flare Type RT	N/A
N/A	Flare Slope LT (%)	N/A	N/A	Flare Slope RT (%)	N/A
N/A	Flare Traversable LT?	N/A	N/A	Flare Traversable RT?	N/A
N/A	Landing Length (in)	N/A	N/A	DWS Provided?	N/A
N/A	Landing Width (in)	N/A	N/A	DWS Contrast?	N/A
N/A	Landing Slope (%)	N/A	N/A	DWS Length (in)	N/A
N/A	Landing X Slope (%)	N/A	N/A	DWS Full Width?	N/A
N/A	Landing Curb? (Y/N)	N/A	N/A	DWS Offset (in)	N/A
N/A	Shared Landing?	N/A			
N/A	Gutter Ponding?	N/A	N/A	Gutter Slope (%)	N/A
N/A	Gutter Lip Ht (in)	N/A	N/A	Gutter X Slope (%)	N/A
N/A	Painted X Walk1?	No	N/A	Painted X Walk2?	No
	X Walk 1 Direction	To E		X Walk 2 Direction	To N
N/A	X Walk 1 Width (in)	N/A	N/A	X Walk 2 Width (in)	N/A
	X Walk 1 Slope (%)	4.2		X Walk 2 Slope (%)	11.9
	X Walk 1 X Slope (%)	7.4		X Walk 2 X Slope (%)	3.6

N/A	Ramp inside XWalk1?	N/A	N/A	Ramp inside XWalk2?	N/A
	Road Slope (%)	5.5	N/A	Clear Space?	N/A
	Road X Slope (%)	8.0	N/A	Clear Space to XWalk (in)	N/A
N/A	Any Obstructions?	N/A	N/A	Storm Grate/Utility Hazard?	N/A
	Obstruction Type			Storm Grate/Utility Type	
		N/A			N/A
			Yes	Surface Condition? (G/P)	Good

Remove & Replace Curb Ramp With Two New Directional Ramps or Equivalent.
