Access Compliance Report

Public Rights-of-Way

(Curb Ramps)

Intersection ID: 9339	Main Street: BADGER_CT	Cross Street: WOODWARD_AV	Location: NW
ADA ID: E9A5E6D66D3E	Ramp Type: Perp	Initial Pass/Fail: Fail	Overall Compliance: No
			Severity Score: 13.75

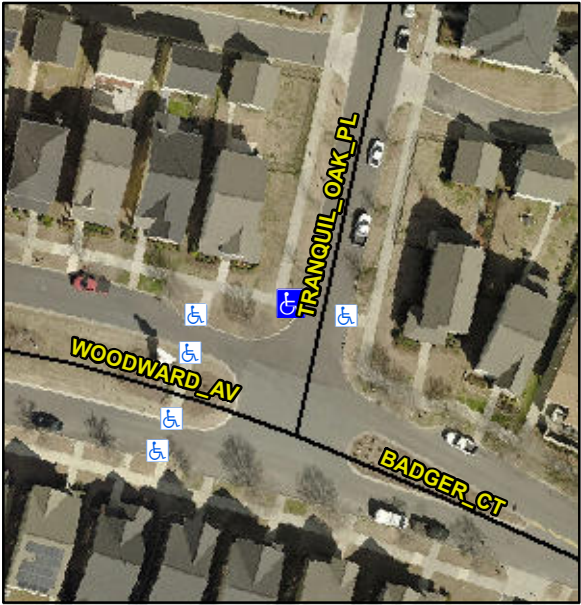
Possible Solutions:		Compliance	Description	Data
	Remove & Replace Entire Ramp.		N/A	Ramp Length (in)	94.5
			Yes	Ramp Width (in)	62.0
			N/A	Flare Type LT	N/A
			N/A	Flare Slope LT (%)	N/A
			N/A	Flare Traversable LT?	N/A
			N/A	Landing Length (in)	N/A
			N/A	Landing Width (in)	N/A
			N/A	Landing Slope (%)	N/A
			N/A	Landing X Slope (%)	N/A
<p>Surveyor Notes:</p> <p>N/A</p> <p>PROW/ADA:</p> <p>R304.2.2, R304.5.3</p>			N/A	Flare Type RT	N/A
			N/A	Flare Slope RT (%)	N/A
			N/A	Flare Traversable RT?	N/A
			N/A	DWS Provided?	N/A
			N/A	DWS Contrast?	N/A
			N/A	DWS Length (in)	N/A
			N/A	DWS Full Width?	N/A
			N/A	DWS Offset (in)	N/A
			N/A	Shared Landing?	N/A
			N/A	Gutter Ponding?	N/A
			N/A	Gutter Lip Ht (in)	2.0
			N/A	Painted X Walk1?	No
				X Walk 1 Direction	To E
			N/A	X Walk 1 Width (in)	N/A
				X Walk 1 Slope (%)	1.2
				X Walk 1 X Slope (%)	3.7

N/A	Ramp inside XWalk1?	N/A
				Road Slope (%)	N/A
				Road X Slope (%)	N/A
			N/A	Any Obstructions?	N/A
				Obstruction Type	
Total Cost:		\$ 1850.00			
			N/A		N/A
			Yes	Surface Condition? (G/P)	Good
