# Access Compliance Report

## Public Rights-of-Way

### (Curb Ramps)

Intersection ID: 11748	Main Street: BERRYHILL_RD	Cross Street: FLEETWOOD_DR	Location: E
ADA ID: E9B2800B9939	Ramp Type: BlendTrans1	Initial Pass/Fail: Fail	Overall Compliance: No
Severity Score: 33.75			
Codes/Mitigation Info/Possible Solution		Field Measurements/Component Compliance

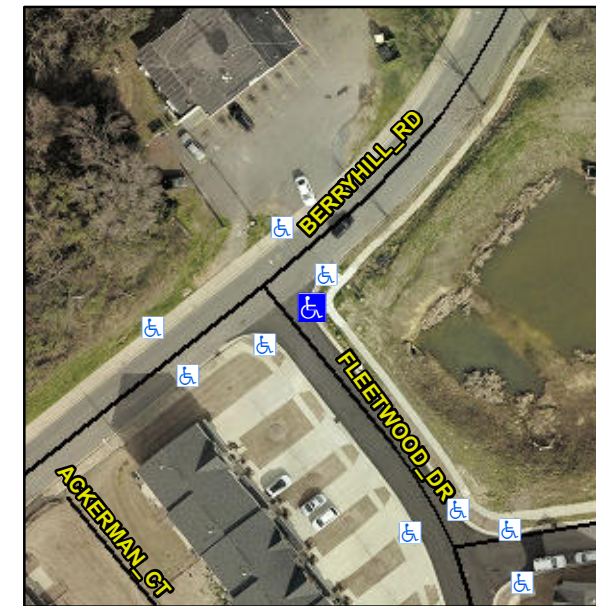
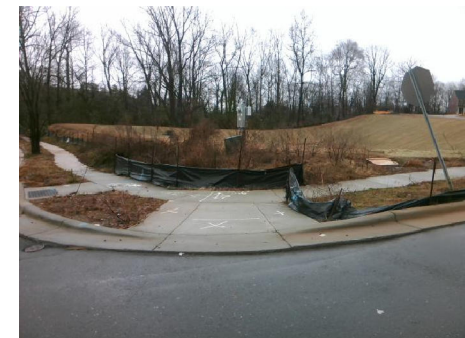
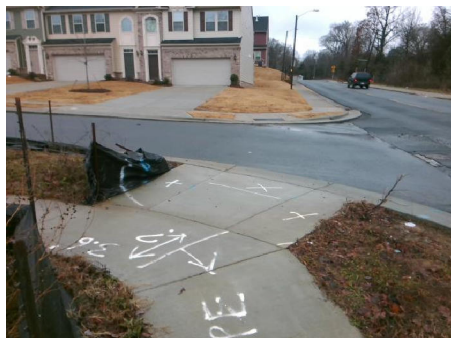
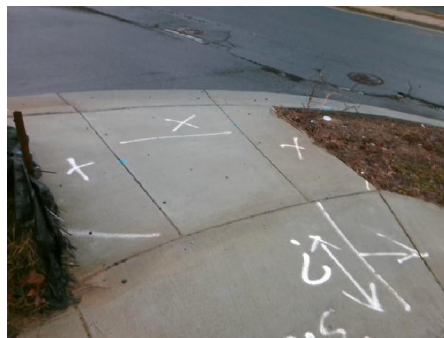
**Not Found, R304.5.1, R304.5.3**

Compliance	Description	Data	Compliance	Description	Data
N/A	Ramp Length (in)	76.5	Yes	BlendTrans Slope (%)	0.6
No	Ramp Width (in)	38.0	No	BlendTrans XSlope (%)	7.2
N/A	Flare Type LT	N/A	N/A	Flare Type RT	N/A
N/A	Flare Slope LT (%)	N/A	N/A	Flare Slope RT (%)	N/A
N/A	Flare Traversable LT?	N/A	N/A	Flare Traversable RT?	N/A
N/A	Landing Length (in)	N/A	N/A	DWS Provided?	N/A
N/A	Landing Width (in)	N/A	N/A	DWS Contrast?	N/A
N/A	Landing Slope (%)	N/A	N/A	DWS Length (in)	N/A
N/A	Landing X Slope (%)	N/A	N/A	DWS Full Width?	N/A
N/A	Landing Curb? (Y/N)	N/A	N/A	DWS Offset (in)	N/A
N/A	Shared Landing?	N/A			
N/A	Gutter Ponding?	N/A	N/A	Gutter Slope (%)	N/A
N/A	Gutter Lip Ht (in)	N/A	N/A	Gutter X Slope (%)	N/A
N/A	Painted X Walk1?	No	N/A	Painted X Walk2?	N/A
	X Walk 1 Direction	To SW		X Walk 2 Direction	N/A
	X Walk 1 Width (in)	N/A		X Walk 2 Width (in)	N/A
	X Walk 1 Slope (%)	4.3		X Walk 2 Slope (%)	N/A
	X Walk 1 X Slope (%)	4.1		X Walk 2 X Slope (%)	N/A

N/A	Ramp inside XWalk1?	N/A	N/A	Ramp inside XWalk2?	N/A
	Road Slope (%)	4.1		Clear Space?	N/A
	Road X Slope (%)	4.3	N/A	Clear Space to XWalk (in)	N/A
N/A	Any Obstructions?	N/A	N/A	Storm Grate/Utility Hazard?	N/A
	Obstruction Type			Storm Grate/Utility Type	
		N/A			N/A
			Yes	Surface Condition? (G/P)	Good
			No	Curb Slope (%)	9.5

**Remove & Replace Curb Ramp With Two New Directional Ramps or Equivalent.**
