Access Compliance Report

Public Rights-of-Way

(Curb Ramps)

Intersection ID: N/A	Main Street: SPEER_BV	Cross Street: NATIONAL_AV	Location: NE
ADA ID: E9BA7A054B43	Ramp Type: Directional1	Initial Pass/Fail: Pass	Overall Compliance: No
Severity Score: 5.25			
Codes/Mitigation Info/Possible Solution		Field Measurements/Component Compliance

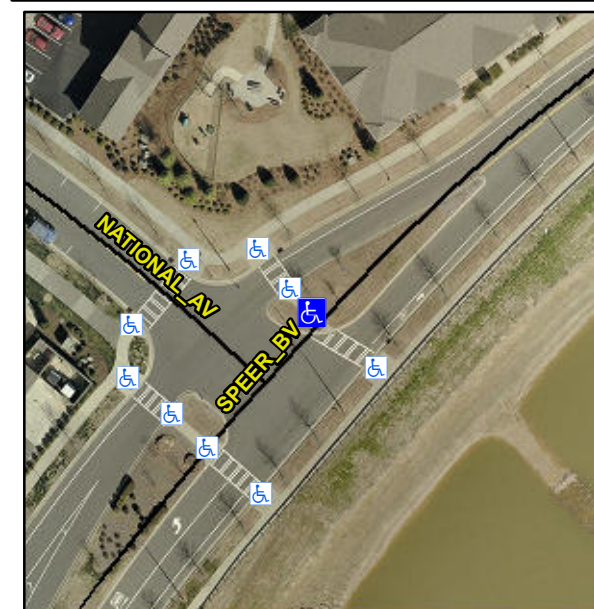
LOCATED ON MEDIAN

R304.5.3, R304.5.4

Compliance	Description	Data	Compliance	Description	Data
N/A	Ramp Length (in)	110.0	N/A	Grade Break?	N/A
Yes	Ramp Width (in)	52.0	N/A	Grade Break Slope (%)	0.0
Yes	Ramp Slope (%)	1.7	N/A	Grade Break XSlope (%)	0.0
No	Ramp XSlope (%)	2.9			
N/A	Flare Type LT	N/A	N/A	Flare Type RT	N/A
N/A	Flare Slope LT (%)	15.1	N/A	Flare Slope RT (%)	8.9
N/A	Flare Traversable LT?	No	N/A	Flare Traversable RT?	No
Yes	Landing Length (in)	52.0	Yes	DWS Provided?	Yes
Yes	Landing Width (in)	54.0	Yes	DWS Contrast?	Yes
Yes	Landing Slope (%)	1.0	Yes	DWS Length (in)	24.0
Yes	Landing X Slope (%)	1.5	Yes	DWS Full Width?	Yes
N/A	Landing Curb? (Y/N)	No	Yes	DWS Offset LT (in)	0.0
N/A	Shared Landing?	Yes	Yes	DWS Offset RT (in)	26.0
Yes	Gutter Ponding?	No	No	Gutter Slope (%)	6.5
Yes	Gutter Lip Ht (in)	0.0	Yes	Gutter X Slope (%)	1.2
N/A	Painted X Walk1?	Yes		Road Slope (%)	4.8
	X Walk 1 Direction	To SE		Road X Slope (%)	2.0
	X Walk 1 Width (in)	112.0		Clear Space?	Yes

X Walk 1 Slope (%)	4.8	N/A	Clear Space to XWalk (in)	N/A
	X Walk 1 X Slope (%)	2.0	Yes	Storm Grate/Utility Hazard?	No
Yes	Ramp inside XWalk1?	Yes		Storm Grate/Utility Type	
Yes	Any Obstructions?	No			N/A
	Obstruction Type		Yes	Surface Condition? (G/P)	Good
			N/A	Curb Slope (%)	2.3

Possible Solutions:

**Remove & Replace Entire Ramp.
Remove & Replace Gutter.**
