# Access Compliance Report

## Public Rights-of-Way

### (Curb Ramps)

Intersection ID: 17718	Main Street: N_SHARON_AMITY_RD	Cross Street: TANGLE_DR	Location: N
ADA ID: E9CCCB6BEAAC	Ramp Type: PerpDiag	Initial Pass/Fail: Fail	Overall Compliance: No
Severity Score: 13.75			
Codes/Mitigation Info/Possible Solution		Field Measurements/Component Compliance

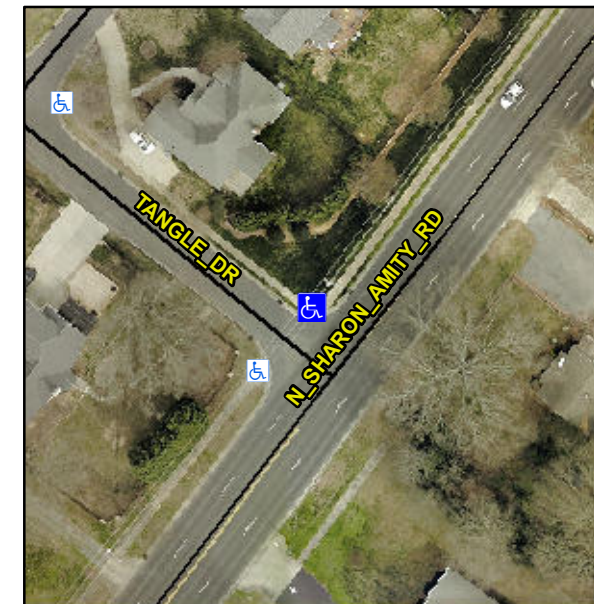
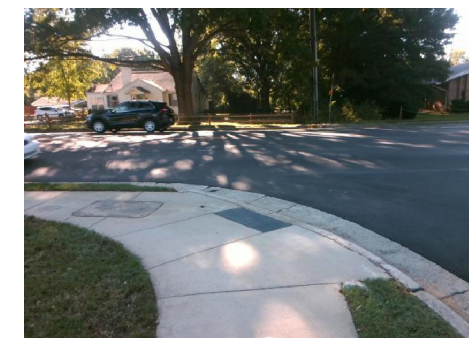
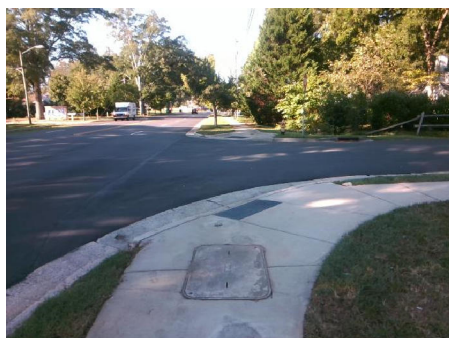
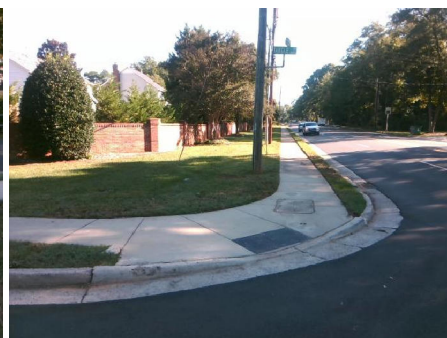
**R304.2.2, R304.5.3**

Compliance	Description	Data	Compliance	Description	Data
N/A	Ramp Length (in)	88.0	No	Ramp Slope (%)	8.7
Yes	Ramp Width (in)	49.0	No	Ramp XSlope (%)	3.7
N/A	Flare Type LT	N/A	N/A	Flare Type RT	N/A
N/A	Flare Slope LT (%)	N/A	N/A	Flare Slope RT (%)	N/A
N/A	Flare Traversable LT?	N/A	N/A	Flare Traversable RT?	N/A
N/A	Landing Length (in)	N/A	N/A	DWS Provided?	N/A
N/A	Landing Width (in)	N/A	N/A	DWS Contrast?	N/A
N/A	Landing Slope (%)	N/A	N/A	DWS Length (in)	N/A
N/A	Landing X Slope (%)	N/A	N/A	DWS Full Width?	N/A
N/A	Landing Curb? (Y/N)	N/A	N/A	DWS Offset (in)	N/A
N/A	Shared Landing?	N/A			
N/A	Gutter Ponding?	N/A	N/A	Gutter Slope (%)	N/A
N/A	Gutter Lip Ht (in)	N/A	N/A	Gutter X Slope (%)	N/A
N/A	Painted X Walk1?	No	N/A	Painted X Walk2?	No
	X Walk 1 Direction	To SW		X Walk 2 Direction	To SE
N/A	X Walk 1 Width (in)	N/A	N/A	X Walk 2 Width (in)	N/A
	X Walk 1 Slope (%)	5.4		X Walk 2 Slope (%)	3.7
	X Walk 1 X Slope (%)	3.6		X Walk 2 X Slope (%)	5.8

N/A	Ramp inside XWalk1?	N/A	N/A	Ramp inside XWalk2?	N/A
	Road Slope (%)	2.3	N/A	Clear Space?	N/A
	Road X Slope (%)	6.2	N/A	Clear Space to XWalk (in)	N/A
N/A	Any Obstructions?	N/A	N/A	Storm Grate/Utility Hazard?	N/A
	Obstruction Type			Storm Grate/Utility Type	
		N/A			N/A
		Yes		Surface Condition? (G/P)	Good

**Remove & Replace Curb Ramp With Two New Directional Ramps or Equivalent.**
