Access Compliance Report Public Rights-of-Way (Curb Ramps)

Intersection ID: N/AMain Street:WINSLET_DRCross Street: N/ALocation:NWADA ID: E9CF4139EDE6Ramp Type:PerpDiagInitial Pass/Fail:FailOverall Compliance: NoSeverity Score:25

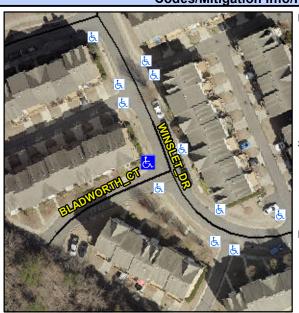
PROW/ADA:
Not Found, R304.2.2

r leid Measurements/Component Comphance						
Compliance Description		Data	Compliance Description		Data	
N/A	Ramp Length (in)	38.0	No	Ramp Slope (%)	12.4	
Yes	Ramp Width (in)	48.0	Yes	Ramp XSlope (%)	0.4	
N/A	Flare Type LT	N/A	N/A	Flare Type RT	N/A	
N/A	Flare Slope LT (%)	N/A	N/A	Flare Slope RT (%)	N/A	
N/A	Flare Traversable LT?	N/A	N/A	Flare Traversable RT?	N/A	
N/A	Landing Length (in)	N/A	N/A	DWS Provided?	N/A	
N/A	Landing Width (in)	N/A	N/A	DWS Contrast?	N/A	
N/A	Landing Slope (%)	N/A	N/A	DWS Length (in)	N/A	
N/A	Landing X Slope (%)	N/A	N/A	DWS Full Width?	N/A	
N/A	Landing Curb? (Y/N)	N/A	N/A	DWS Offset (in)	N/A	
N/A	Shared Landing?	N/A				
N/A	Gutter Ponding?	N/A	N/A	Gutter Slope (%)	N/A	
N/A	Gutter Lip Ht (in)	N/A	N/A	Gutter X Slope (%)	N/A	
N/A	Painted X Walk1?	No	N/A	Painted X Walk2?	No	
	X Walk 1 Direction	To S		X Walk 2 Direction	ТоЕ	
N/A	X Walk 1 Width (in)	N/A	N/A	X Walk 2 Width (in)	N/A	
	X Walk 1 Slope (%)	2.8		X Walk 2 Slope (%)	2.4

X Walk 1 X Slope (%)	2.2		X Walk 2 X Slope (%)	2.1	
N/A	Ramp inside XWalk1?	N/A	N/A	Ramp inside XWalk2?	N/A	
	Road Slope (%)	0.3	N/A	Clear Space?	N/A	
	Road X Slope (%)	3.5	N/A	Clear Space to XWalk (in)	N/A	
N/A	Any Obstructions?	N/A	N/A	Storm Grate/Utility Hazard?	N/A

Remove & Replace Curb Ramp With
Two New Directional Ramps or
Equivalent.
