Access Compliance Report Public Rights-of-Way (Curb Ramps)

Intersection ID: N/A Main Street: NORTH_COMMUNITY_HOUSE_RDss Street: TORINGDON_WY Location: W

ADA ID: E9E5021878EB Ramp Type: PerpDiag Initial Pass/Fail: Fail Overall Compliance: No Severity Score: 12.5

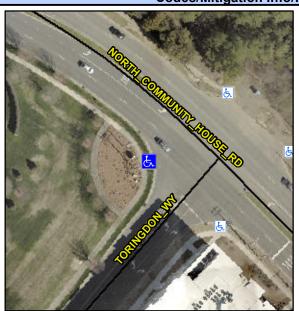
Compliance Description Data Compliance Description Data Yes N/A Ramp Length (in) 97.0 Ramp Slope (%) 7.6 No Ramp XSlope (%) Yes Ramp Width (in) 52.0 5.2 N/A N/A Flare Type LT N/A Flare Type RT N/A N/A N/A N/A Flare Slope RT (%) N/A Flare Slope LT (%) N/A Flare Traversable LT? N/A N/A Flare Traversable RT? N/A N/A N/A N/A DWS Provided? N/A Landing Length (in) N/A Landing Width (in) N/A N/A **DWS Contrast?** N/A N/A N/A N/A Landing Slope (%) DWS Length (in) N/A N/A Landing X Slope (%) N/A N/A DWS Full Width? N/A N/A Landing Curb? (Y/N) N/A N/A DWS Offset (in) N/A N/A N/A Shared Landing? N/A **Gutter Ponding?** N/A N/A Gutter Slope (%) N/A N/A Gutter Lip Ht (in) N/A N/A Gutter X Slope (%) N/A N/A Painted X Walk1? No N/A Painted X Walk2? No X Walk 1 Direction To SE X Walk 2 Direction To NE N/A N/A X Walk 1 Width (in) X Walk 2 Width (in) N/A X Walk 1 Slope (%) 3.9 X Walk 2 Slope (%) 0.1 X Walk 1 X Slope (%) 1.4 X Walk 2 X Slope (%) 4.7 N/A N/A N/A Ramp inside XWalk2? N/A Ramp inside XWalk1? Road Slope (%) 1.4 N/A Clear Space? N/A N/A Road X Slope (%) 5.4 Clear Space to XWalk (in) N/A N/A N/A Any Obstructions? N/A Storm Grate/Utility Hazard? N/A **Obstruction Type** Storm Grate/Utility Type N/A N/A Yes Surface Condition? (G/P) Good

Possible Solutions:

Remove & Replace Curb Ramp With
Two New Directional Ramps or
Equivalent.

R304.5.3
