Access Compliance Report

Public Rights-of-Way

(Curb Ramps)

Intersection ID: 18776	Main Street: SOUTH_BV	Cross Street: TYVOLA_RD	Location: NE
ADA ID: E9EFB4673C58	Ramp Type: Perp	Initial Pass/Fail: Pass	Overall Compliance: No
Codes/Mitigation Info/Possible Solution		Field Measurements/Component Compliance	
Severity Score: 10.25

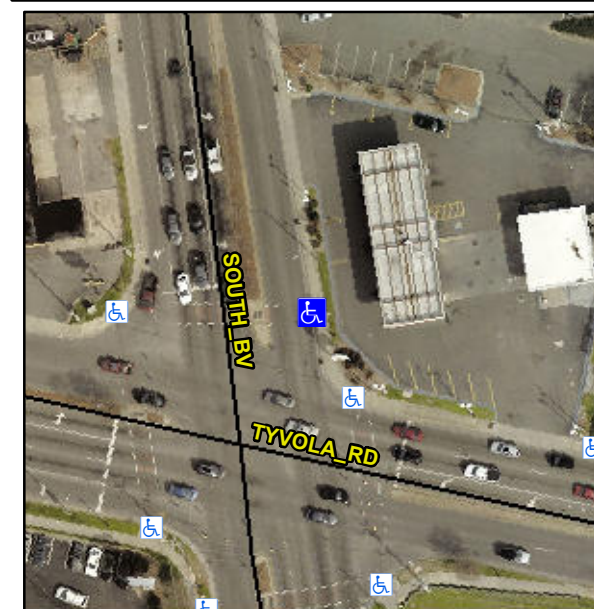
Compliance	Description	Data	Compliance	Description	Data
N/A	Ramp Length (in)	69.0	Yes	Ramp Slope (%)	7.5
Yes	Ramp Width (in)	48.0	No	Ramp XSlope (%)	2.3
N/A	Flare Type LT	Sloped	N/A	Flare Type RT	N/A
N/A	Flare Slope LT (%)	6.2	Yes	Flare Slope RT (%)	4.5
N/A	Flare Traversable LT?	Yes	N/A	Flare Traversable RT?	Yes
No	Landing Length (in)	N/A	Yes	DWS Provided?	Yes
No	Landing Width (in)	N/A	Yes	DWS Contrast?	Yes
No	Landing Slope (%)	N/A	Yes	DWS Length (in)	24.0
No	Landing X Slope (%)	N/A	Yes	DWS Full Width?	Yes
N/A	Landing Curb? (Y/N)	Yes	Yes	DWS Offset (in)	0.0
N/A	Shared Landing?	No			
Yes	Gutter Ponding?	No	Yes	Gutter Slope (%)	4.3
Yes	Gutter Lip Ht (in)	0.0	Yes	Gutter X Slope (%)	1.3
N/A	Painted X Walk1?	Yes	N/A	Painted X Walk2?	N/A
	X Walk 1 Direction	To W		X Walk 2 Direction	N/A
N/A	X Walk 1 Width (in)	116.0	N/A	X Walk 2 Width (in)	N/A
	X Walk 1 Slope (%)	2.9		X Walk 2 Slope (%)	N/A
	X Walk 1 X Slope (%)	1.0		X Walk 2 X Slope (%)	N/A

Yes	Ramp inside XWalk1?	Yes	N/A	Ramp inside XWalk2?	N/A
	Road Slope (%)	N/A	N/A	Clear Space?	Yes
	Road X Slope (%)	N/A	N/A	Clear Space to XWalk (in)	N/A
Yes	Any Obstructions?	No	Yes	Storm Grate/Utility Hazard?	No
	Obstruction Type			Storm Grate/Utility Type	
		N/A			N/A
			Yes	Surface Condition? (G/P)	Good

Possible Solutions:

Remove & Replace Entire Ramp.

**R304.5.3, R304.2.1, R304.2.2-Perp,
R304.3.2-Para**

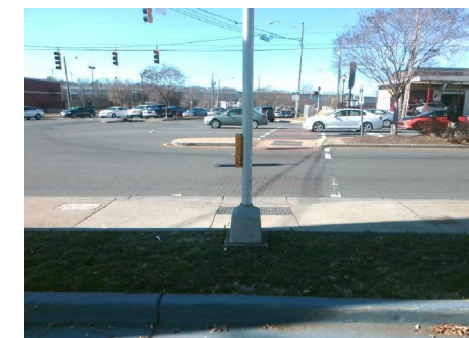
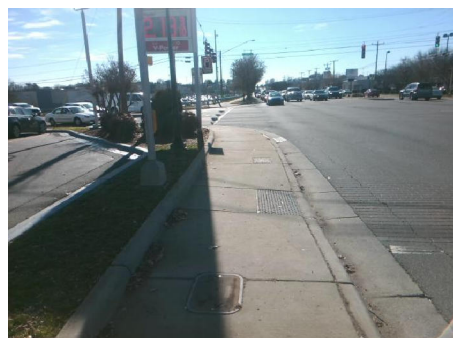
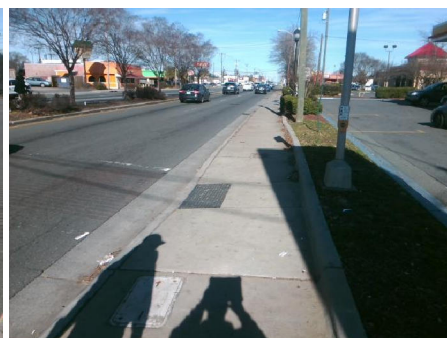
Street 1 Name SOUTH BV
 Stop Condition-Street 2 Signal
 Street 2 Name N/A
 Stop Condition-Street 1 N/A
