Access Compliance Report

Public Rights-of-Way

(Curb Ramps)

Intersection ID: 52918	Main Street: HOOVER_CREEK_BV	Cross Street: STEELE_CREEK_RD	Location: SW
ADA ID: E9F72EAC54CB	Ramp Type: PerpDiag	Initial Pass/Fail: Fail	Overall Compliance: No
Severity Score: 10			
Codes/Mitigation Info/Possible Solution		Field Measurements/Component Compliance

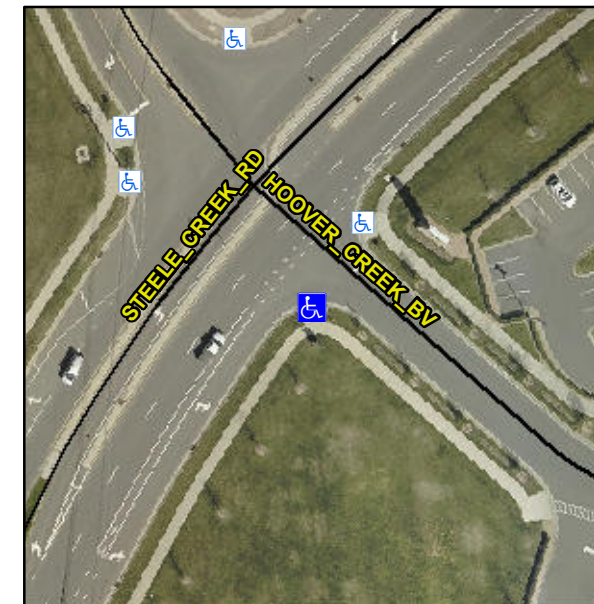
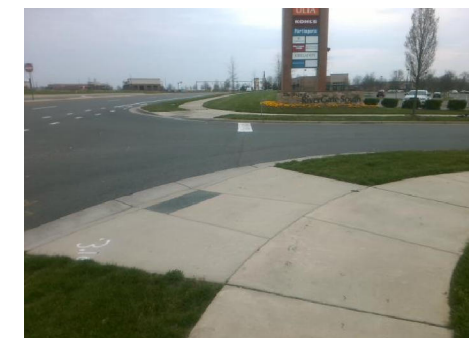
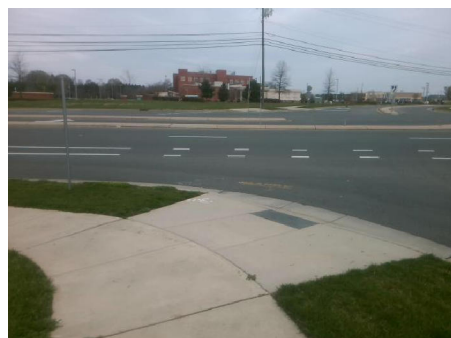
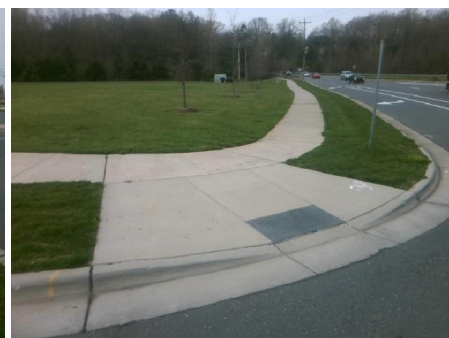
Not Found, R304.5.1, R304.5.3

Compliance	Description	Data	Compliance	Description	Data
N/A	Ramp Length (in)	96.0	Yes	Ramp Slope (%)	6.5
No	Ramp Width (in)	46.0	No	Ramp XSlope (%)	3.6
N/A	Flare Type LT	N/A	N/A	Flare Type RT	N/A
N/A	Flare Slope LT (%)	N/A	N/A	Flare Slope RT (%)	N/A
N/A	Flare Traversable LT?	N/A	N/A	Flare Traversable RT?	N/A
N/A	Landing Length (in)	N/A	N/A	DWS Provided?	N/A
N/A	Landing Width (in)	N/A	N/A	DWS Contrast?	N/A
N/A	Landing Slope (%)	N/A	N/A	DWS Length (in)	N/A
N/A	Landing X Slope (%)	N/A	N/A	DWS Full Width?	N/A
N/A	Landing Curb? (Y/N)	N/A	N/A	DWS Offset (in)	N/A
N/A	Shared Landing?	N/A			
N/A	Gutter Ponding?	N/A	N/A	Gutter Slope (%)	N/A
N/A	Gutter Lip Ht (in)	N/A	N/A	Gutter X Slope (%)	N/A
N/A	Painted X Walk1?	No	N/A	Painted X Walk2?	No
	X Walk 1 Direction	To NE		X Walk 2 Direction	To NW
N/A	X Walk 1 Width (in)	N/A	N/A	X Walk 2 Width (in)	N/A
	X Walk 1 Slope (%)	3.0		X Walk 2 Slope (%)	3.3
	X Walk 1 X Slope (%)	1.0		X Walk 2 X Slope (%)	5.4

N/A	Ramp inside XWalk1?	N/A	N/A	Ramp inside XWalk2?	N/A
	Road Slope (%)	2.1	N/A	Clear Space?	N/A
	Road X Slope (%)	4.3	N/A	Clear Space to XWalk (in)	N/A
N/A	Any Obstructions?	N/A	N/A	Storm Grate/Utility Hazard?	N/A
	Obstruction Type			Storm Grate/Utility Type	
		N/A			N/A
			Yes	Surface Condition? (G/P)	Good

Remove & Replace Curb Ramp With Two New Directional Ramps or Equivalent.
