Access Compliance Report

Public Rights-of-Way

(Curb Ramps)

Intersection ID: 50636	Main Street: BLUE_GROVE_RD	Cross Street: RED_WATER_RD	Location: NE
ADA ID: EA147BB73679	Ramp Type: Perp	Initial Pass/Fail: Fail	Overall Compliance: No
		Severity Score: 10

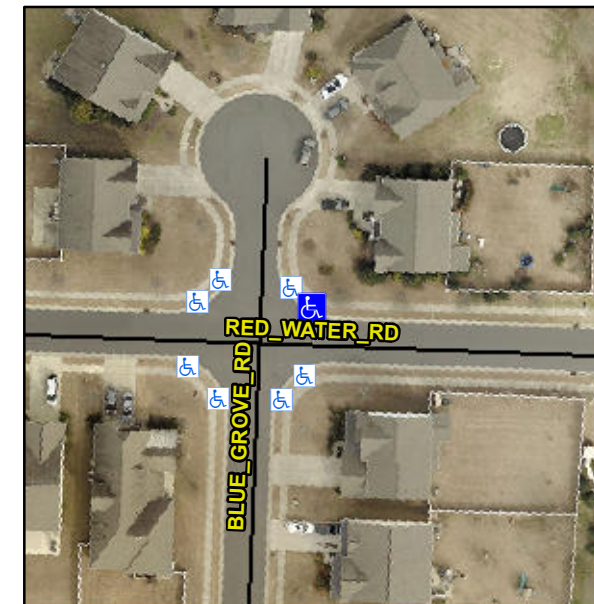
Not Found, R304.5.1, R304.5.3

Compliance	Description	Data	Compliance	Description	Data
N/A	Ramp Length (in)	48.0	Yes	Ramp Slope (%)	7.7
No	Ramp Width (in)	46.0	No	Ramp XSlope (%)	3.4
N/A	Flare Type LT	N/A	N/A	Flare Type RT	N/A
N/A	Flare Slope LT (%)	N/A	N/A	Flare Slope RT (%)	N/A
N/A	Flare Traversable LT?	N/A	N/A	Flare Traversable RT?	N/A
N/A	Landing Length (in)	N/A	N/A	DWS Provided?	N/A
N/A	Landing Width (in)	N/A	N/A	DWS Contrast?	N/A
N/A	Landing Slope (%)	N/A	N/A	DWS Length (in)	N/A
N/A	Landing X Slope (%)	N/A	N/A	DWS Full Width?	N/A
N/A	Landing Curb? (Y/N)	N/A	N/A	DWS Offset (in)	N/A
N/A	Shared Landing?	N/A			
N/A	Gutter Ponding?	N/A	N/A	Gutter Slope (%)	N/A
N/A	Gutter Lip Ht (in)	N/A	N/A	Gutter X Slope (%)	N/A
N/A	Painted X Walk1?	No	N/A	Painted X Walk2?	N/A
	X Walk 1 Direction	To SW		X Walk 2 Direction	N/A
N/A	X Walk 1 Width (in)	N/A	N/A	X Walk 2 Width (in)	N/A
	X Walk 1 Slope (%)	0.6		X Walk 2 Slope (%)	N/A
	X Walk 1 X Slope (%)	2.7		X Walk 2 X Slope (%)	N/A

N/A	Ramp inside XWalk1?	N/A	N/A	Ramp inside XWalk2?	N/A
	Road Slope (%)	N/A	N/A	Clear Space?	N/A
	Road X Slope (%)	N/A	N/A	Clear Space to XWalk (in)	N/A
N/A	Any Obstructions?	N/A	N/A	Storm Grate/Utility Hazard?	N/A
	Obstruction Type			Storm Grate/Utility Type	
		N/A			N/A
			Yes	Surface Condition? (G/P)	Good

Remove & Replace Entire Ramp.
