# Access Compliance Report

## Public Rights-of-Way

### (Curb Ramps)

Intersection ID: 19406	Main Street: SOUTH_BV	Cross Street: BOURBON_ST	Location: NW
ADA ID: EA1C08F7D5B2	Ramp Type: Perp	Initial Pass/Fail: Fail	Overall Compliance: No
Severity Score: 22.5			
Codes/Mitigation Info/Possible Solution		Field Measurements/Component Compliance

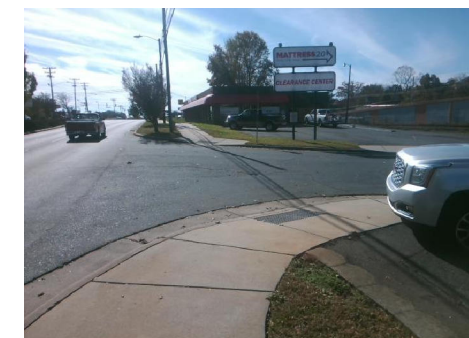
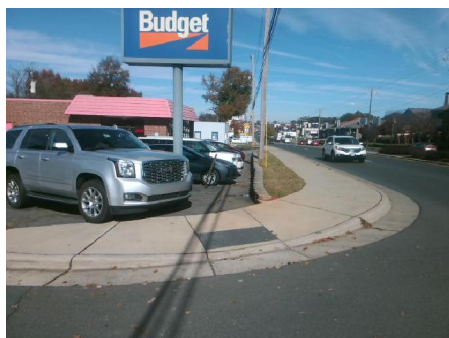
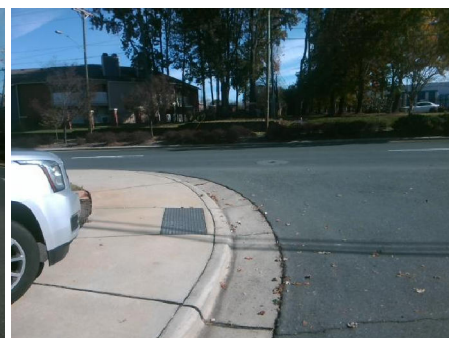
**Not Found, R304.5.1, R304.2.2, R304.5.3**

Compliance	Description	Data	Compliance	Description	Data
N/A	Ramp Length (in)	72.0	No	Ramp Slope (%)	8.8
No	Ramp Width (in)	47.0	No	Ramp XSlope (%)	4.2
N/A	Flare Type LT	N/A	N/A	Flare Type RT	N/A
N/A	Flare Slope LT (%)	N/A	N/A	Flare Slope RT (%)	N/A
N/A	Flare Traversable LT?	N/A	N/A	Flare Traversable RT?	N/A
N/A	Landing Length (in)	N/A	N/A	DWS Provided?	N/A
N/A	Landing Width (in)	N/A	N/A	DWS Contrast?	N/A
N/A	Landing Slope (%)	N/A	N/A	DWS Length (in)	N/A
N/A	Landing X Slope (%)	N/A	N/A	DWS Full Width?	N/A
N/A	Landing Curb? (Y/N)	N/A	N/A	DWS Offset (in)	N/A
N/A	Shared Landing?	N/A			
N/A	Gutter Ponding?	N/A	N/A	Gutter Slope (%)	N/A
N/A	Gutter Lip Ht (in)	N/A	N/A	Gutter X Slope (%)	N/A
N/A	Painted X Walk1?	No	N/A	Painted X Walk2?	N/A
	X Walk 1 Direction	To S		X Walk 2 Direction	N/A
N/A	X Walk 1 Width (in)	N/A	N/A	X Walk 2 Width (in)	N/A
	X Walk 1 Slope (%)	1.9		X Walk 2 Slope (%)	N/A
	X Walk 1 X Slope (%)	5.3		X Walk 2 X Slope (%)	N/A

N/A	Ramp inside XWalk1?	N/A	N/A	Ramp inside XWalk2?	N/A
	Road Slope (%)	N/A	N/A	Clear Space?	N/A
	Road X Slope (%)	N/A	N/A	Clear Space to XWalk (in)	N/A
N/A	Any Obstructions?	N/A	N/A	Storm Grate/Utility Hazard?	N/A
	Obstruction Type			Storm Grate/Utility Type	
		N/A			N/A
			Yes	Surface Condition? (G/P)	Good

**Remove & Replace Entire Ramp.**
