Access Compliance Report

Public Rights-of-Way

(Curb Ramps)

Intersection ID: 12052	Main Street: E_17TH_ST	Cross Street: PEGRAM_ST	Location: E
ADA ID: EA2A0630B2CC	Ramp Type: BlendTrans1	Initial Pass/Fail: Fail	Overall Compliance: No
		Severity Score: 8.75	
Codes/Mitigation Info/Possible Solution		Field Measurements/Component Compliance

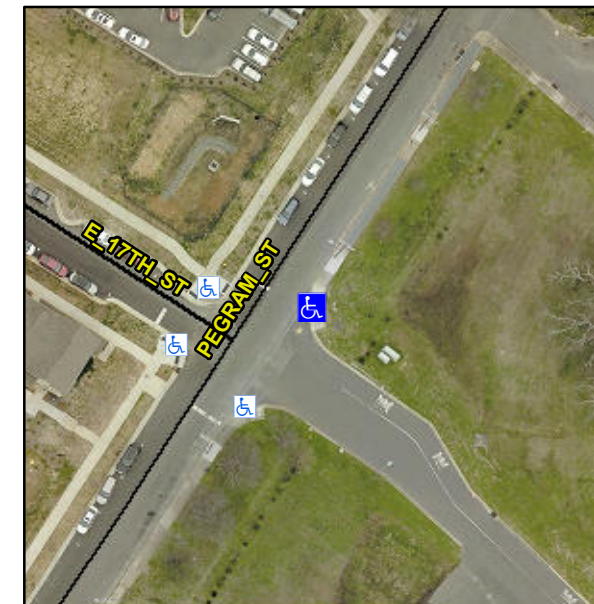
Surveyor Notes:

DAMAGED CURB

PROW/ADA:

R304.5.1

Compliance	Description	Data	Compliance	Description	Data
N/A	Ramp Length (in)	73.0	Yes	BlendTrans Slope (%)	2.1
No	Ramp Width (in)	42.0	Yes	BlendTrans XSlope (%)	1.1
N/A	Flare Type LT	N/A	N/A	Flare Type RT	N/A
N/A	Flare Slope LT (%)	N/A	N/A	Flare Slope RT (%)	N/A
N/A	Flare Traversable LT?	N/A	N/A	Flare Traversable RT?	N/A
N/A	Landing Length (in)	N/A	N/A	DWS Provided?	N/A
N/A	Landing Width (in)	N/A	N/A	DWS Contrast?	N/A
N/A	Landing Slope (%)	N/A	N/A	DWS Length (in)	N/A
N/A	Landing X Slope (%)	N/A	N/A	DWS Full Width?	N/A
N/A	Landing Curb? (Y/N)	N/A	N/A	DWS Offset (in)	N/A
N/A	Shared Landing?	N/A			
N/A	Gutter Ponding?	N/A	N/A	Gutter Slope (%)	N/A
N/A	Gutter Lip Ht (in)	N/A	N/A	Gutter X Slope (%)	N/A
N/A	Painted X Walk1?	No	N/A	Painted X Walk2?	No
	X Walk 1 Direction	To NW		X Walk 2 Direction	To SW
	X Walk 1 Width (in)	N/A		X Walk 2 Width (in)	N/A
	X Walk 1 Slope (%)	5.3		X Walk 2 Slope (%)	0.6
	X Walk 1 X Slope (%)	1.2		X Walk 2 X Slope (%)	3.2

N/A	Ramp inside XWalk1?	N/A	N/A	Ramp inside XWalk2?	N/A
	Road Slope (%)	1.3		Clear Space?	N/A
	Road X Slope (%)	5.4	N/A	Clear Space to XWalk (in)	N/A
N/A	Any Obstructions?	N/A	N/A	Storm Grate/Utility Hazard?	N/A
	Obstruction Type			Storm Grate/Utility Type	
		N/A			N/A
			Yes	Surface Condition? (G/P)	Good
			N/A	Curb Slope (%)	4.8

Possible Solutions:

Remove & Replace Curb Ramp With Two New Directional Ramps or Equivalent.
