## **Access Compliance Report Public Rights-of-Way** (Curb Ramps)

Intersection ID: 8498 Main Street: KENNEDY ST **Cross Street: N GRAHAM ST** Location: **Overall Compliance: No** ADA ID: EA355DA23075 Ramp Type: Combination2 Initial Pass/Fail: Fail Severity Score: 33.75

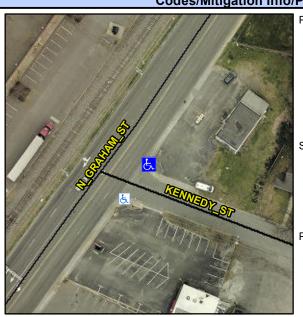
StopSign Street 1 Name Stop Condition-Street 1 **KENNEDY ST** N/A Street 2 Name Stop Condition-Street 2 N/A Possible Solutions: Compliance Description N/A Remove & Replace Entire Ramp. Yes Yes Yes N/A No Surveyor Notes: N/A **RT RP < 5%** N/A N/A N/A N/A PROW/ADA N/A Not Found, R304.5.1, R304.2.2, N/A R304.5.3 N/A N/A
