Access Compliance Report

Public Rights-of-Way

(Curb Ramps)

Intersection ID: 14014	Main Street: N_SHARON_AMITY_RD	Cross Street: WILORA_LAKE_RD	Location: SE
ADA ID: EA50F65FA8DC	Ramp Type: Perp	Initial Pass/Fail: Fail	Overall Compliance: No
Codes/Mitigation Info/Possible Solution		Field Measurements/Component Compliance	
Severity Score: 21.25

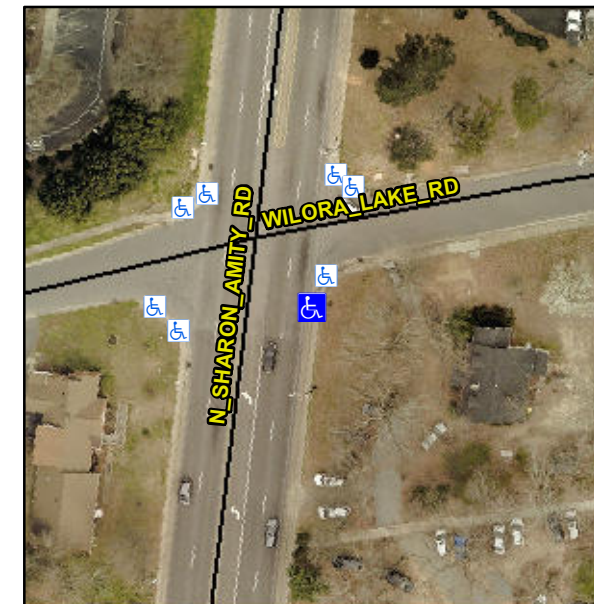
Not Found, R304.5.1, R304.2.2

Compliance	Description	Data	Compliance	Description	Data
N/A	Ramp Length (in)	59.0	No	Ramp Slope (%)	9.5
No	Ramp Width (in)	44.0	Yes	Ramp XSlope (%)	0.2
N/A	Flare Type LT	N/A	N/A	Flare Type RT	N/A
N/A	Flare Slope LT (%)	N/A	N/A	Flare Slope RT (%)	N/A
N/A	Flare Traversable LT?	N/A	N/A	Flare Traversable RT?	N/A
N/A	Landing Length (in)	N/A	N/A	DWS Provided?	N/A
N/A	Landing Width (in)	N/A	N/A	DWS Contrast?	N/A
N/A	Landing Slope (%)	N/A	N/A	DWS Length (in)	N/A
N/A	Landing X Slope (%)	N/A	N/A	DWS Full Width?	N/A
N/A	Landing Curb? (Y/N)	N/A	N/A	DWS Offset (in)	N/A
N/A	Shared Landing?	N/A			
N/A	Gutter Ponding?	N/A	N/A	Gutter Slope (%)	N/A
N/A	Gutter Lip Ht (in)	N/A	N/A	Gutter X Slope (%)	N/A
N/A	Painted X Walk1?	No	N/A	Painted X Walk2?	N/A
	X Walk 1 Direction	To W		X Walk 2 Direction	N/A
N/A	X Walk 1 Width (in)	N/A	N/A	X Walk 2 Width (in)	N/A
	X Walk 1 Slope (%)	4.6		X Walk 2 Slope (%)	N/A
	X Walk 1 X Slope (%)	1.9		X Walk 2 X Slope (%)	N/A

Remove & Replace Entire Ramp.

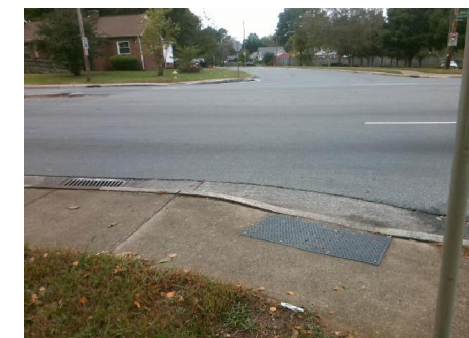
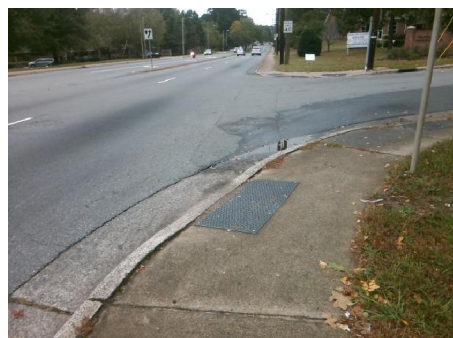
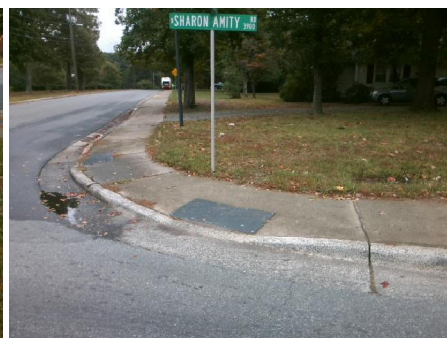
N/A	Ramp inside XWalk1?	N/A	N/A	Ramp inside XWalk2?	N/A
	Road Slope (%)	N/A	N/A	Clear Space?	N/A
	Road X Slope (%)	N/A	N/A	Clear Space to XWalk (in)	N/A
N/A	Any Obstructions?	N/A	N/A	Storm Grate/Utility Hazard?	N/A
	Obstruction Type			Storm Grate/Utility Type	
		N/A			N/A
			Yes	Surface Condition? (G/P)	Good
