Access Compliance Report

Public Rights-of-Way

(Curb Ramps)

Intersection ID: 50636	Main Street: BLUE_GROVE_RD	Cross Street: RED_WATER_RD	Location: SE
ADA ID: EA56B9A6E3D1	Ramp Type: Perp	Initial Pass/Fail: Fail	Overall Compliance: No
Codes/Mitigation Info/Possible Solution		Field Measurements/Component Compliance

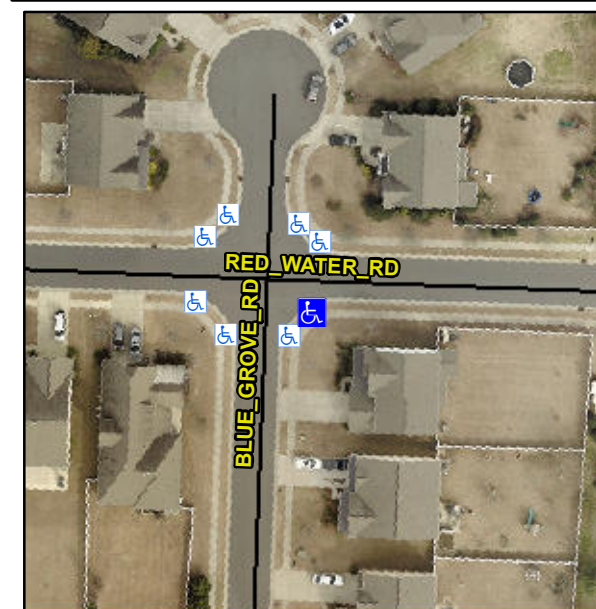
Not Found, R304.5.1, R304.5.3

Compliance	Description	Data	Compliance	Description	Data
N/A	Ramp Length (in)	48.0	Yes	Ramp Slope (%)	7.9
No	Ramp Width (in)	46.5	No	Ramp XSlope (%)	3.3
N/A	Flare Type LT	N/A	N/A	Flare Type RT	N/A
N/A	Flare Slope LT (%)	N/A	N/A	Flare Slope RT (%)	N/A
N/A	Flare Traversable LT?	N/A	N/A	Flare Traversable RT?	N/A
N/A	Landing Length (in)	N/A	N/A	DWS Provided?	N/A
N/A	Landing Width (in)	N/A	N/A	DWS Contrast?	N/A
N/A	Landing Slope (%)	N/A	N/A	DWS Length (in)	N/A
N/A	Landing X Slope (%)	N/A	N/A	DWS Full Width?	N/A
N/A	Landing Curb? (Y/N)	N/A	N/A	DWS Offset (in)	N/A
N/A	Shared Landing?	N/A			
N/A	Gutter Ponding?	N/A	N/A	Gutter Slope (%)	N/A
N/A	Gutter Lip Ht (in)	N/A	N/A	Gutter X Slope (%)	N/A
N/A	Painted X Walk1?	No	N/A	Painted X Walk2?	N/A
	X Walk 1 Direction	To NE		X Walk 2 Direction	N/A
N/A	X Walk 1 Width (in)	N/A	N/A	X Walk 2 Width (in)	N/A
	X Walk 1 Slope (%)	4.6		X Walk 2 Slope (%)	N/A
	X Walk 1 X Slope (%)	0.2		X Walk 2 X Slope (%)	N/A

N/A	Ramp inside XWalk1?	N/A	N/A	Ramp inside XWalk2?	N/A
	Road Slope (%)	N/A	N/A	Clear Space?	N/A
	Road X Slope (%)	N/A	N/A	Clear Space to XWalk (in)	N/A
N/A	Any Obstructions?	N/A	N/A	Storm Grate/Utility Hazard?	N/A
	Obstruction Type			Storm Grate/Utility Type	
		N/A			N/A
			Yes	Surface Condition? (G/P)	Good

Possible Solutions:

Remove & Replace Entire Ramp.
