# Access Compliance Report

## Public Rights-of-Way

### (Curb Ramps)

Intersection ID: 49295	Main Street: CREEKSIDE_PARK_RD	Cross Street: ROYAL_WINCHESTER_DR	Location: SW
ADA ID: EA6AFB252460	Ramp Type: Perp	Initial Pass/Fail: Pass	Overall Compliance: No
Codes/Mitigation Info/Possible Solution		Field Measurements/Component Compliance	
Severity Score: 0

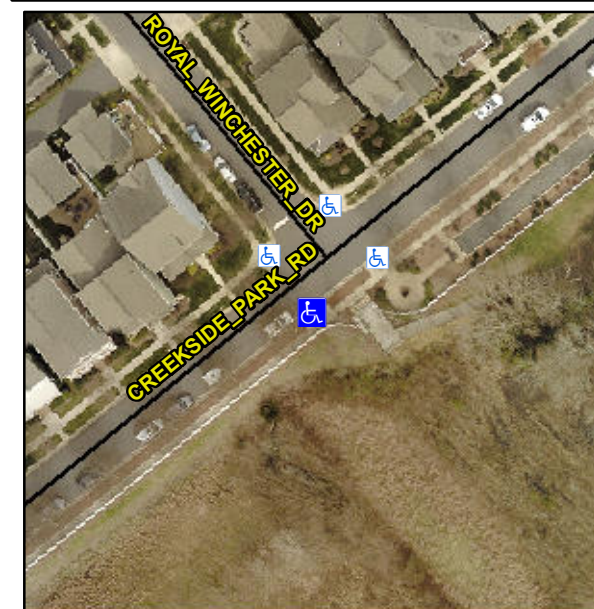
Compliance	Description	Data	Compliance	Description	Data
N/A	Ramp Length (in)	72.0	Yes	Ramp Slope (%)	7.1
Yes	Ramp Width (in)	48.0	Yes	Ramp XSlope (%)	1.2
N/A	Flare Type LT	Sloped	N/A	Flare Type RT	N/A
N/A	Flare Slope LT (%)	6.9	Yes	Flare Slope RT (%)	3.7
N/A	Flare Traversable LT?	Yes	N/A	Flare Traversable RT?	Yes
Yes	Landing Length (in)	48.0	Yes	DWS Provided?	Yes
Yes	Landing Width (in)	48.0	Yes	DWS Contrast?	Yes
No	Landing Slope (%)	2.5	Yes	DWS Length (in)	24.5
No	Landing X Slope (%)	3.1	Yes	DWS Full Width?	Yes
N/A	Landing Curb? (Y/N)	No	Yes	DWS Offset (in)	0.0
N/A	Shared Landing?	No			
Yes	Gutter Ponding?	No	Yes	Gutter Slope (%)	1.6
Yes	Gutter Lip Ht (in)	0.0	Yes	Gutter X Slope (%)	1.7
N/A	Painted X Walk1?	No	N/A	Painted X Walk2?	N/A
	X Walk 1 Direction	To NW		X Walk 2 Direction	N/A
N/A	X Walk 1 Width (in)	N/A	N/A	X Walk 2 Width (in)	N/A
	X Walk 1 Slope (%)	0.6		X Walk 2 Slope (%)	N/A
	X Walk 1 X Slope (%)	1.0		X Walk 2 X Slope (%)	N/A

N/A	Ramp inside XWalk1?	N/A	N/A	Ramp inside XWalk2?	N/A
	Road Slope (%)	N/A	N/A	Clear Space?	Yes
	Road X Slope (%)	N/A	N/A	Clear Space to XWalk (in)	N/A
Yes	Any Obstructions?	No	Yes	Storm Grate/Utility Hazard?	No
	Obstruction Type			Storm Grate/Utility Type	
		N/A			N/A
			Yes	Surface Condition? (G/P)	Good

**Remove & Replace Entire Ramp.**
