## Access Compliance Report Public Rights-of-Way (Curb Ramps)

Intersection ID: 42804	Main St	reet: AUDREY_LAKE_DR	Cross	Cross Street: SAWMILL_TRACE_DR				Location:	NW
ADA ID: EA786105AE62	Ramp T	Ramp Type: PerpDiag			ail: Fail Overall C	nce: N	o Severity Score:	25	
Codes/Mitigation Info/Possible Solution				Field Measurements/Component Compliance					
	A	Possible Solutions:		Compliance Description		Data Compliance Description			Data
		Remove & Replace Curb Ramp	With	N/A	Ramp Length (in)	52.0	Yes	Ramp Slope (%)	6.6
		Two New Directional Ramps		Yes	Ramp Width (in)	48.0	No	Ramp XSlope (%)	7.0
Contract Contract of Contract		Equivalent.		N/A	Flare Type LT	N/A	N/A	Flare Type RT	N/A
Contraction of the second s				N/A	Flare Slope LT (%)	N/A	N/A	Flare Slope RT (%)	N/A
				N/A	Flare Traversable LT?	N/A	N/A	Flare Traversable RT?	N/A
A DECK PI		<u>e</u>		N/A	Landing Length (in)	N/A	N/A	DWS Provided?	N/A
The second se		Surveyor Notes:		N/A	Landing Width (in)	N/A	N/A	DWS Contrast?	N/A

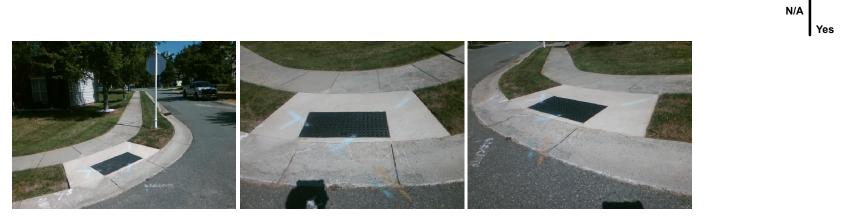
the sectors and	N/A		N/A	Landing Slope (%)	N/A	N/A	DWS Length (in)	N/A
SAWMILL_JI	RACEDR			N/A	Landing X Slope (%)	N/A	N/A	DWS Full Width?	N/A
			N/A	Landing Curb? (Y/N)	N/A	N/A	DWS Offset (in)	N/A	
PROW/ADA: Not Found, R304.5.3				N/A	Shared Landing?	N/A			
				N/A	Gutter Ponding?	N/A	N/A	Gutter Slope (%)	N/A
				N/A	Gutter Lip Ht (in)	N/A	N/A	Gutter X Slope (%)	N/A
				N/A	Painted X Walk1?	No	N/A	Painted X Walk2?	No No
				N/A	X Walk 1 Direction	To S	IN/A	X Walk 2 Direction	To E
				NI/A					
				N/A	X Walk 1 Width (in)	N/A	N/A	X Walk 2 Width (in)	N/A
Street 1 Name	SAWMILL TRACE DR				X Walk 1 Slope (%)	1.7		X Walk 2 Slope (%)	0.5
Stop Condition-Street 2	None				X Walk 1 X Slope (%)	0.9		X Walk 2 X Slope (%)	5.0
Street 2 Name	AUDREY LAKE DR			N/A	Ramp inside XWalk1?	N/A		Ramp inside XWalk2?	N/A
Stop Condition-Street 1	StopSign				Road Slope (%)	2.5	N/A	Clear Space?	N/A
					Road X Slope (%)	1.5	N/A	Clear Space to XWalk (in)	N/A

N/A	Any Obstructions?	N/A	N/A	Storm Grate/Utility Hazard?	N/A
		Total Cost: \$	3200.00		Obstruction Type			Storm Grate/Utility Type	
						N/A			N/A
