# Access Compliance Report

## Public Rights-of-Way

### (Curb Ramps)

Intersection ID: 7876	Main Street: BROOKTREE_DR	Cross Street: N/A	Location: SW
ADA ID: EA843D709155	Ramp Type: Directional1	Initial Pass/Fail: Fail	Overall Compliance: No
			Severity Score: 33.75

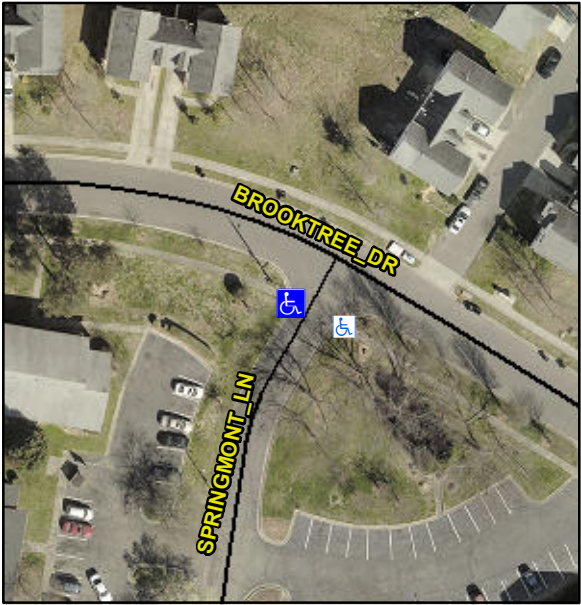
Possible Solutions:		<b>Compliance</b>	<b>Description</b>	<b>Data</b>	
	<b>Remove &amp; Replace Entire Ramp.</b>		<b>N/A</b>	Ramp Length (in)	<b>46.5</b>	<b>N/A</b>
			<b>No</b>	Ramp Width (in)	<b>47.0</b>	<b>N/A</b>
			<b>No</b>	Ramp Slope (%)	<b>12.2</b>	<b>N/A</b>
			<b>Yes</b>	Ramp XSlope (%)	<b>0.9</b>	
			<b>N/A</b>	Flare Type LT	<b>N/A</b>	<b>N/A</b>
			<b>N/A</b>	Flare Slope LT (%)	<b>N/A</b>	<b>N/A</b>
			<b>N/A</b>	Flare Traversable LT?	<b>N/A</b>	<b>N/A</b>
			<b>N/A</b>	Landing Length (in)	<b>0.0</b>	<b>N/A</b>
			<b>N/A</b>	Landing Width (in)	<b>0.0</b>	<b>N/A</b>
			<b>N/A</b>	Landing Slope (%)	<b>0.0</b>	<b>N/A</b>
			<b>N/A</b>	Landing X Slope (%)	<b>0.0</b>	<b>N/A</b>
			<b>N/A</b>	Landing Curb? (Y/N)	<b>N/A</b>	<b>N/A</b>
			<b>N/A</b>	Shared Landing?	<b>N/A</b>	<b>N/A</b>
			<b>N/A</b>	Gutter Ponding?	<b>0.0</b>	<b>N/A</b>

<b>N/A</b>	Gutter Lip Ht (in)	<b>0.0</b>	<b>N/A</b>
			<b>N/A</b>	Painted X Walk1?	<b>No</b>	<b>N/A</b>
				X Walk 1 Direction	<b>To E</b>	<b>N/A</b>
				X Walk 1 Width (in)	<b>N/A</b>	<b>N/A</b>
				X Walk 1 Slope (%)	<b>0.8</b>	<b>N/A</b>
				X Walk 1 X Slope (%)	<b>5.2</b>	<b>N/A</b>
			<b>N/A</b>	Ramp inside XWalk1?	<b>N/A</b>	<b>N/A</b>
			<b>N/A</b>	Any Obstructions?	<b>N/A</b>	<b>N/A</b>
				Obstruction Type		<b>N/A</b>
					<b>Yes</b>	<b>N/A</b>
					<b>N/A</b>	<b>N/A</b>
						<b>Good</b>
						<b>22.5</b>
Surveyor Notes:						
N/A						
PROW/ADA:						
R304.5.1, R304.2.2						
Total Cost:						
\$ 1600.00
