# Access Compliance Report

## Public Rights-of-Way

### (Curb Ramps)

Intersection ID: 51011	Main Street: TREMONT_PLACE_RD	Cross Street: BENDING_BRANCH_RD	Location: E
ADA ID: EA843DF9C985	Ramp Type: Perp	Initial Pass/Fail: Fail	Overall Compliance: No
Severity Score: 22.5			
Codes/Mitigation Info/Possible Solution		Field Measurements/Component Compliance

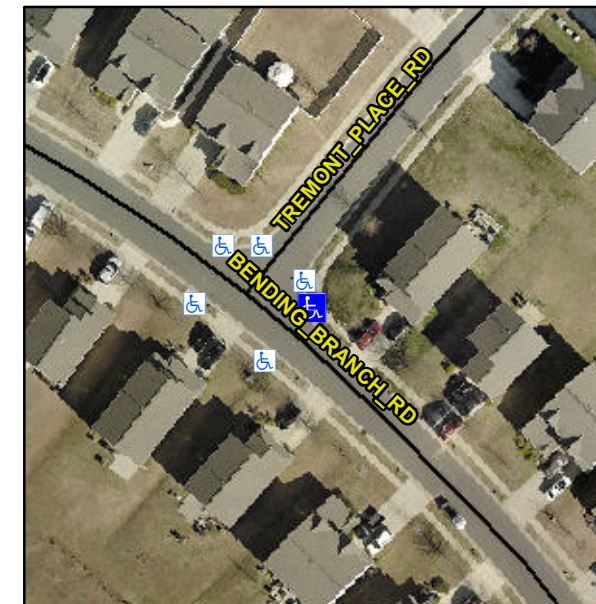
**Not Found, R304.5.1, R304.2.2**

Compliance	Description	Data	Compliance	Description	Data
N/A	Ramp Length (in)	49.0	No	Ramp Slope (%)	8.4
No	Ramp Width (in)	47.5	Yes	Ramp XSlope (%)	3.2
N/A	Flare Type LT	N/A	N/A	Flare Type RT	N/A
N/A	Flare Slope LT (%)	N/A	N/A	Flare Slope RT (%)	N/A
N/A	Flare Traversable LT?	N/A	N/A	Flare Traversable RT?	N/A
N/A	Landing Length (in)	N/A	N/A	DWS Provided?	N/A
N/A	Landing Width (in)	N/A	N/A	DWS Contrast?	N/A
N/A	Landing Slope (%)	N/A	N/A	DWS Length (in)	N/A
N/A	Landing X Slope (%)	N/A	N/A	DWS Full Width?	N/A
N/A	Landing Curb? (Y/N)	N/A	N/A	DWS Offset (in)	N/A
N/A	Shared Landing?	N/A			
N/A	Gutter Ponding?	N/A	N/A	Gutter Slope (%)	N/A
N/A	Gutter Lip Ht (in)	N/A	N/A	Gutter X Slope (%)	N/A
N/A	Painted X Walk1?	No	N/A	Painted X Walk2?	N/A
	X Walk 1 Direction	To SW		X Walk 2 Direction	N/A
N/A	X Walk 1 Width (in)	N/A	N/A	X Walk 2 Width (in)	N/A
	X Walk 1 Slope (%)	2.4		X Walk 2 Slope (%)	N/A
	X Walk 1 X Slope (%)	3.2		X Walk 2 X Slope (%)	N/A

N/A	Ramp inside XWalk1?	N/A	N/A	Ramp inside XWalk2?	N/A
	Road Slope (%)	N/A	N/A	Clear Space?	N/A
	Road X Slope (%)	N/A	N/A	Clear Space to XWalk (in)	N/A
N/A	Any Obstructions?	N/A	N/A	Storm Grate/Utility Hazard?	N/A
	Obstruction Type			Storm Grate/Utility Type	
		N/A			N/A
			Yes	Surface Condition? (G/P)	Good

**Remove & Replace Entire Ramp.**
