# Access Compliance Report

## Public Rights-of-Way

### (Curb Ramps)

Intersection ID: 10031842	Main Street: MINTWORTH_AV	Cross Street: N/A	Location: SE
ADA ID: EA8A14E303E5	Ramp Type: Perp	Initial Pass/Fail: Fail	Overall Compliance: No
Codes/Mitigation Info/Possible Solution		Field Measurements/Component Compliance	
Severity Score: 12.5

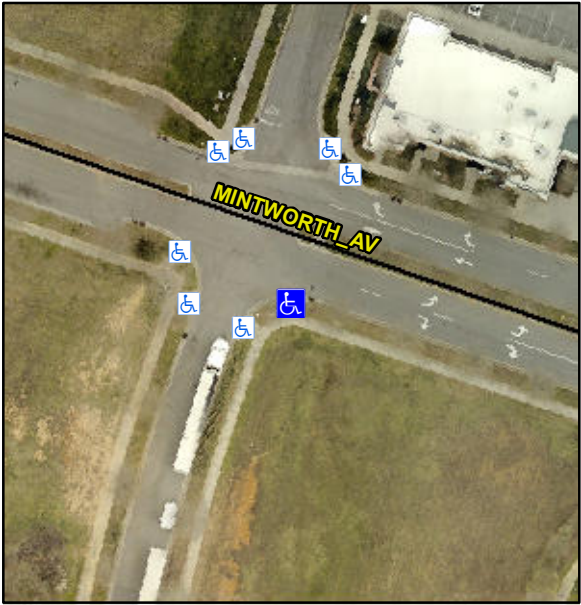
Possible Solutions:	Compliance	Description	Data	Compliance	Description	Data
	Remove & Replace Entire Ramp.	N/A	Ramp Length (in)	97.0	Yes	Ramp Slope (%)	7.1
		Yes	Ramp Width (in)	48.0	No	Ramp XSlope (%)	6.2
		N/A	Flare Type LT	N/A	N/A	Flare Type RT	N/A
		N/A	Flare Slope LT (%)	N/A	N/A	Flare Slope RT (%)	N/A
		N/A	Flare Traversable LT?	N/A	N/A	Flare Traversable RT?	N/A
		N/A	Landing Length (in)	N/A	N/A	DWS Provided?	N/A
		N/A	Landing Width (in)	N/A	N/A	DWS Contrast?	N/A
		N/A	Landing Slope (%)	N/A	N/A	DWS Length (in)	N/A
		N/A	Landing X Slope (%)	N/A	N/A	DWS Full Width?	N/A
<p>Surveyor Notes:</p> <p>N/A</p> <p>PROW/ADA:</p> <p>Not Found, R304.5.3</p>		N/A	Landing Curb? (Y/N)	N/A	N/A	DWS Offset (in)	N/A
		N/A	Shared Landing?	N/A			
		N/A	Gutter Ponding?	N/A	N/A	Gutter Slope (%)	N/A
		N/A	Gutter Lip Ht (in)	N/A	N/A	Gutter X Slope (%)	N/A
		N/A	Painted X Walk1?	No	N/A	Painted X Walk2?	N/A
			X Walk 1 Direction	To NE		X Walk 2 Direction	N/A

N/A	X Walk 1 Width (in)	N/A	N/A	X Walk 2 Width (in)	N/A
			X Walk 1 Slope (%)	1.3		X Walk 2 Slope (%)	N/A
			X Walk 1 X Slope (%)	4.0		X Walk 2 X Slope (%)	N/A
		N/A	Ramp inside XWalk1?	N/A	N/A	Ramp inside XWalk2?	N/A
<p>Street 1 Name</p> <p>Stop Condition-Street 2</p> <p>Street 2 Name</p> <p>Stop Condition-Street 1</p>			Road Slope (%)	N/A	N/A	Clear Space?	N/A
			Road X Slope (%)	N/A	N/A	Clear Space to XWalk (in)	N/A
		N/A	Any Obstructions?	N/A	N/A	Storm Grate/Utility Hazard?	N/A
			Obstruction Type			Storm Grate/Utility Type	
					N/A		N/A
					Yes	Surface Condition? (G/P)	Good
Total Cost:		\$	1850.00
