# Access Compliance Report

## Public Rights-of-Way

| Intersection ID: 14757 | Main Street: E_WORTHINGTON_AV | Cross Street: LENNOX_AV | Location: E |
| ADA ID: EA9CAF3F959C | Ramp Type: BlendTrans1 | Initial Pass/Fail: Fail | Overall Compliance: No |

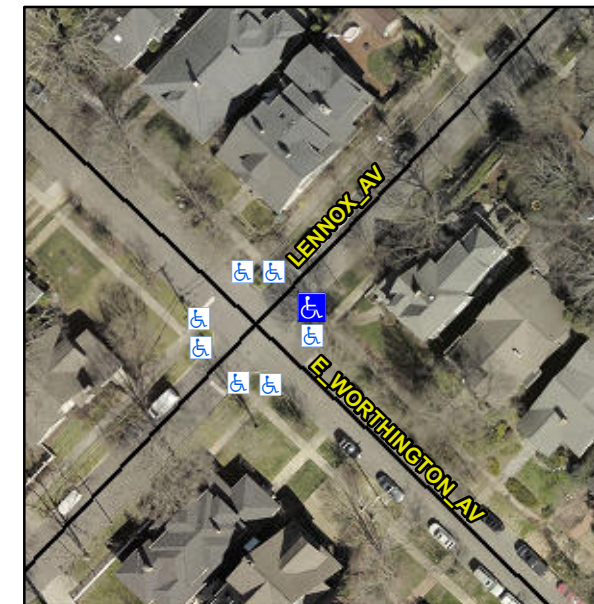
**DAMAGED CURB**

**R304.5.3**

| Compliance | Description | Data | Compliance | Description | Data |
|---|---|---|---|---|---|
| Yes | Ramp Width (in) | 59.5 | No | BlendTrans XSlope (%) | 3.5 |

**Remove & Replace Curb Ramp With Two New Directional Ramps or Equivalent.**
