## Access Compliance Report Public Rights-of-Way (Curb Ramps)

Intersection ID: 22899Main Street:LAUREL\_TRACE\_DRCross Street:OAKBRIAR\_LNLocation:NEADA ID: EACDC1C134A1Ramp Type:PerpInitial Pass/Fail:FailOverall Compliance:NoSeverity Score:13.75

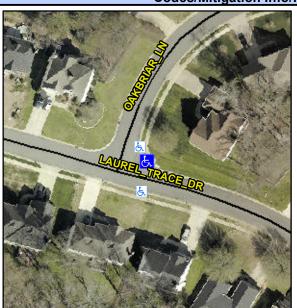
Not Found, R304.2.2, R304.5.3

| Field Measurements/Component Compliance | | | | | | | |
|---|---|---|---|---|---|--|--|
| N/A | Ramp Length (in) | 44.0 | No | Ramp Slope (%) | 8.7 | | |
| Yes | Ramp Width (in) | 48.0 | No | Ramp XSlope (%) | 2.5 | | |

Remove & Replace Entire Ramp.
